**ANATOLIA ANTIQUA  
ESKİ ANADOLU**

Olivier HENRY\*

## LA MISSION LABRAUNDA 2013 – RAPPORT PRELIMINAIRE

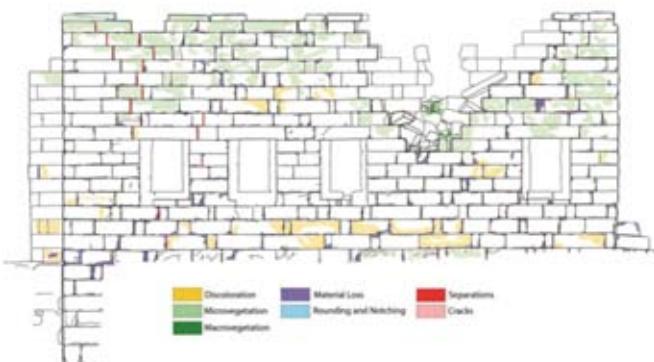
**Fig. 3 : Mapping of visual weathering forms on south facade (© METU, 2012).**

As a part of the geological and material studies, stone samples with no archaeological importance were collected for laboratory analysis. Density, sound velocity, porosity, XRD mineralogical analysis and petrographic analyzes by optical microscopy of thin sections were conducted over these samples, in order to define the physical and physico-mechanical properties of these rocks. It revealed that the building stones used in the *Andron A* are gneiss, with high unit weight, effective porosity, low water absorption and cation-exchange capacity. Hence, their field performances are good, as long as they are used horizontally parallel to their foliation planes and as long as their contact with water is controlled through good drainage. The observations during the site survey also proved that most of the material problems such as discoloration, flaking, surface relief, rounding and notching at the edges of the blocks and material loss in the upper parts of the building are due to repeated contact with rainwater from surfaces and from the top (Fig. 3).

Thereupon, providing water drainage and delimiting the water entry in between the gneiss blocks from the top or from surfaces of the walls have been among the main concerns of the conservation project. Besides, another common form of degradation is the loss of material by eruptions due to the effects of plant roots growing on the walls, which necessitated intervention. There are also micro vegetation such as fungi, algae and lichens. However, as no clear adverse effects of them could be visualized and as removing them is a destructive process causing loss of material from the surface, it is proposed not to intervene on them at the moment, but to monitor their effects on the stone walls in time.

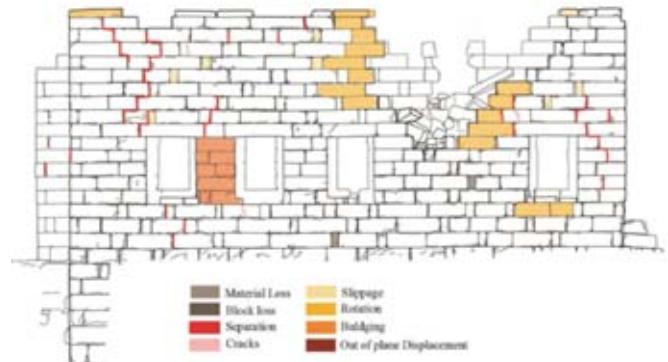
**Fig. 4 : Mapping of structural problems on south facade (© METU, 2012).**

The major conservation issue in *Andron A* is related to its structural stability. Thereupon, comprehensive understanding of the structural condition and of the structural damages became one of the major concerns and tracks of the project<sup>7</sup>. As the first stage of the structural studies, structural problems were detected during the site survey, which were then mapped on the measured drawings of the building. Accordingly, material loss, block loss, separation, slippage, rotation, bulging and out of plane displacement are the structural problems which can be visualized in *Andron A* (Fig. 4).

All these studies revealed that the main problem of the building is the out-of-plane movement under possible seismic forces acting in a north-south direction. The structural problems are mostly concentrated on the south wall, which is leaning towards the south. This leaning causes the separation of the two wall shells, which can be easily visualized through the recessed headers. There are also noticeable vertical cracks on the west wall and the back-wall of the *pronaos* due to the leaning of the south wall. In addition to this, on the upper part of the south wall a triangular area is totally destructed. Moreover, a horizontal bulging at the base part of the south wall can be visualized. Considering the seismic sen-

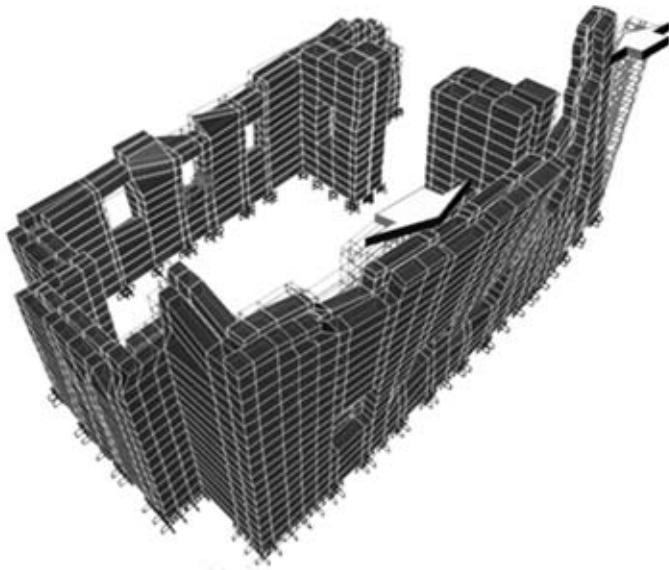
For further analysis and assessments of the structural behavior and problems of the building, a finite element model with a macro modeling approach was created based on the measured drawings (Fig. 5). The analysis over the model helped both understanding the current structural condition and behavior of the building as well as making projections about its future condition and behavior under different forces.

**Fig. 5 : Finite element model of Andron A**  
© METU, 2012).

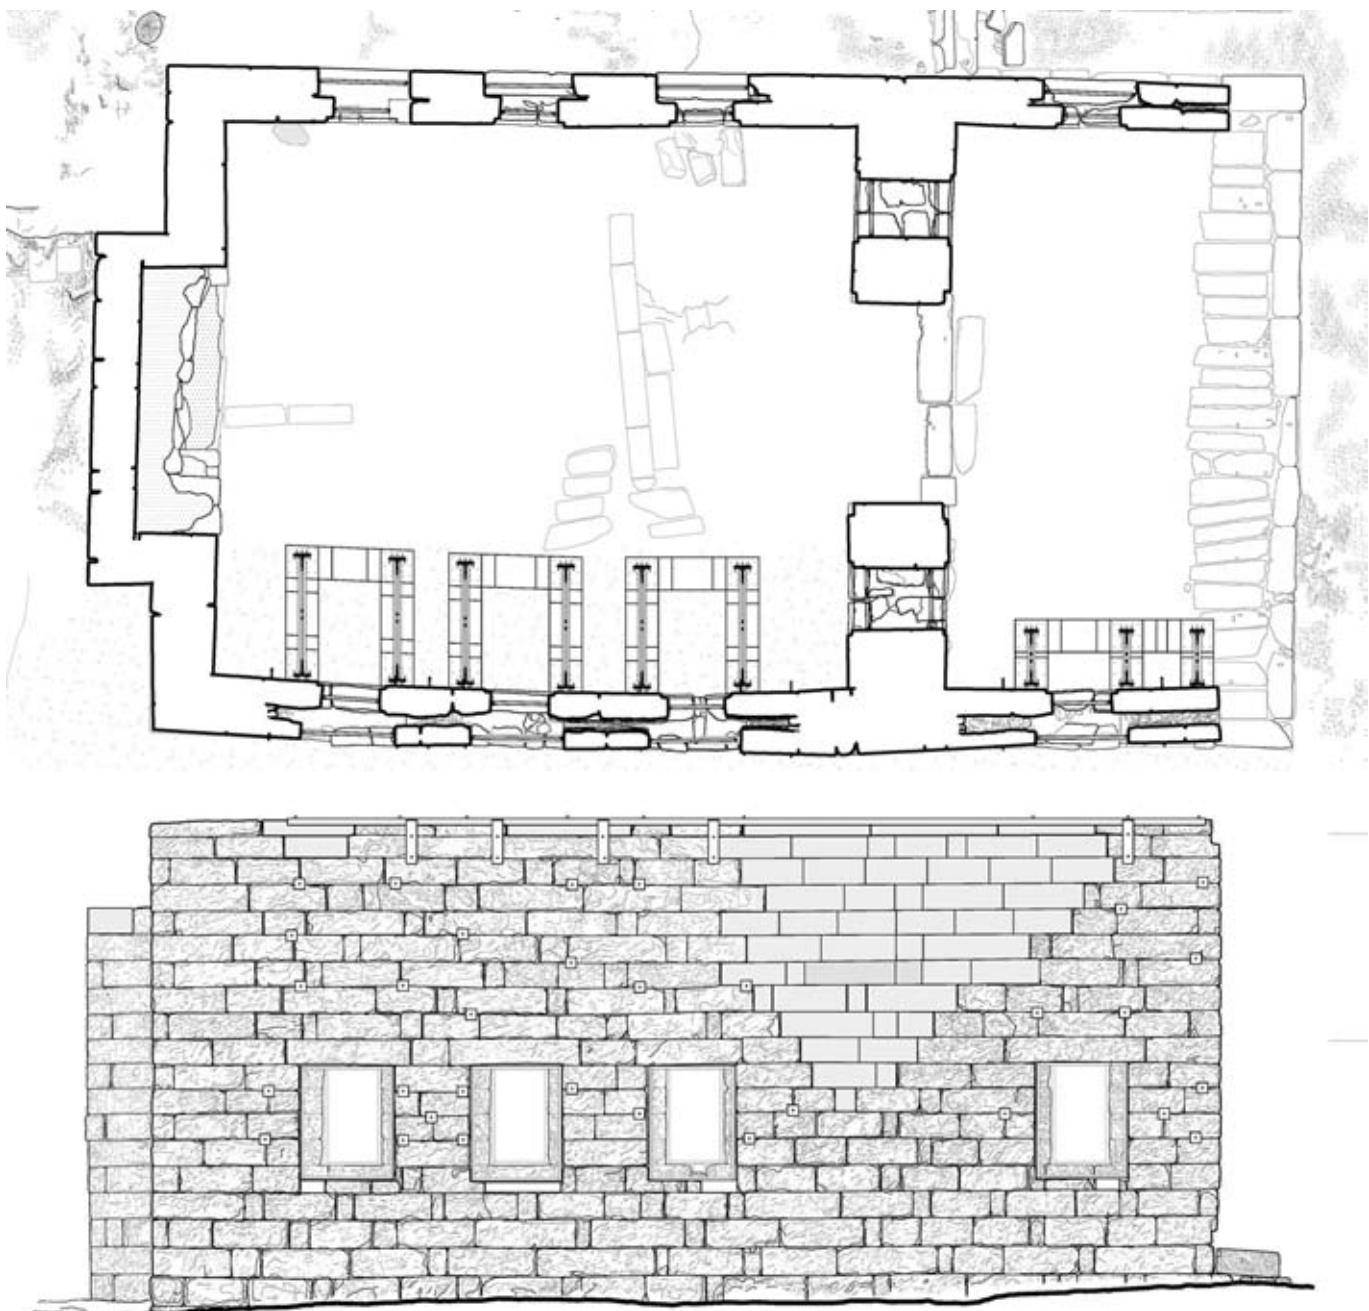
**Fig. 6 : The restoration drawings: plan and south facade (© METU, 2013).**

- doing the preparatory works for conservation interventions and conservation of the original floor plasters;
- supporting the south wall with a temporary scaffolding;

- taking down the unstable and unsafe stone blocks on the south façade;
- supporting the window openings with steel frames;
- filling the cracks and gaps on the walls with repair mortar;
- intervening to the macro vegetation;
- re-stabilizing the lost and deformed parts of the south and east walls by putting back the slipped or slided stones into their original places, changing the existing blocks in bad condition with new gneiss blocks and constructing the lost part of the south facade with gneiss stone blocks in order to provide the structural stability between the south wall and the back wall of the *pronaos*;
- constructing the steel truss strengthening system;
- capping the top of the walls in order to avoid water penetration in between the walls from the top.

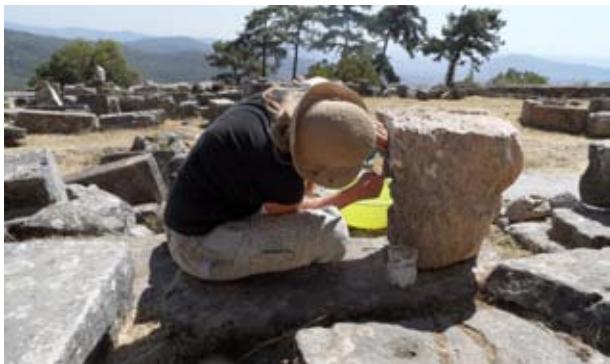
**Fig. 7 : Cleaning of a corinthian capital from the north *Stoa*** (photo : A. Freccero).

Conservation was concentrated to the North Stoa and the five Corinthian capitals of the colonnade that remain (Fig. 7). Two capitals had been prepared last year when they were treated with biocide, as was the large column drum at *Andron B* (Fig. 8). Two objects found in earth this year were cleaned and consolidated. One of these was a frail fragment of an anta capital, and the second was a large fragment of an architrave with inscription (inv. K81) at the South Propylaea. After being found and registered in 1949, the fragment had at some time fallen and been broken into two parts with the inscribed side in the earth. As the broken blocks were lifted the inscription was identified and placed to the left of the entrance of the gateway. A portion of the central part including some letters is missing (Fig. 9). A few minor rearrangements were made at the South Propylaea in connection with the replacement of the broken architrave. The first part of the left side of the architrave, inv. K4, was placed beside the inscribed part, and a fragment of the pediment positioned upon it. Further, the capital of the left anta was placed on an inscribed anta block, thereby approximately mirroring the arrangement on the right hand side, with the anta capital conserved in 2011.

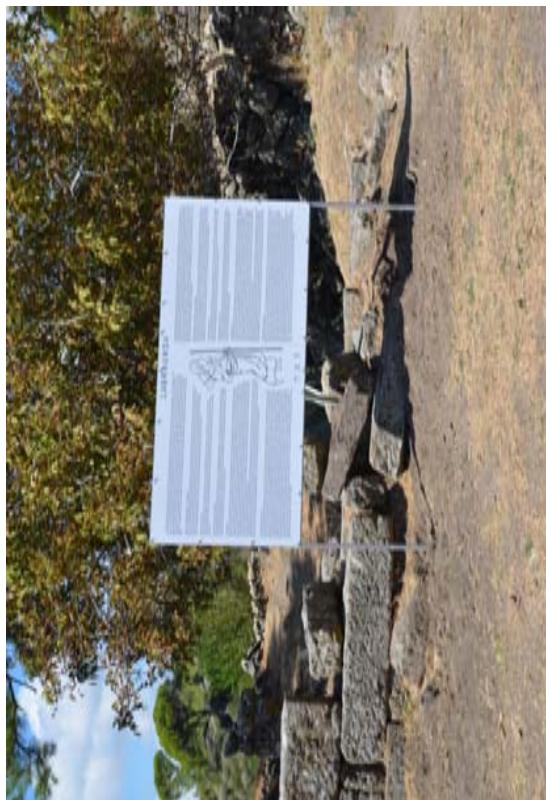
Fig. 15 : La couverture protégeant le sondage profond du bâtiment hypostyle (photo : O. Henry).

Deux sondages profonds, l'un au niveau des bains sud et datant d'une quinzaine d'année, et l'autre au Nord du bâtiment hypostyle (voir *infra* la section 4.4) ont été sécurisés. Une barrière en bois interdit désormais l'accès au premier, tandis qu'une couverture métallique a été appliquée au-dessus du second (Fig. 15).

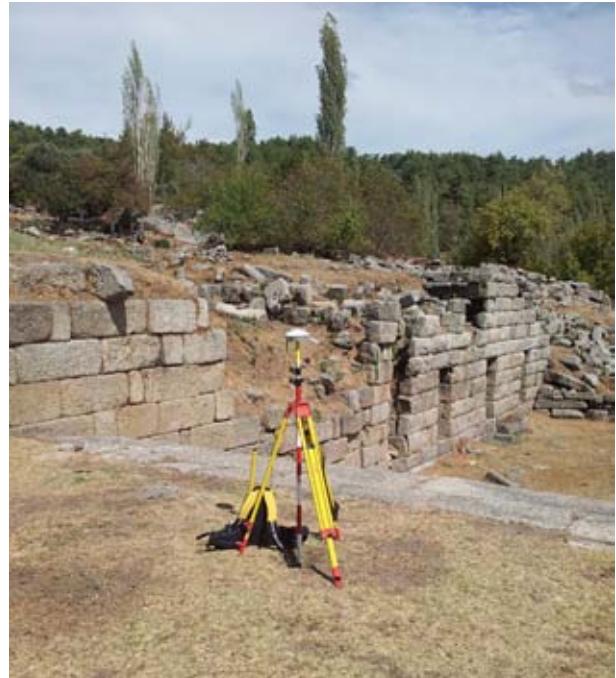
**Fig. 24 : Récepteur GPS bi-fréquences en station** (photo : P. Lebouteiller).

Pour effectuer cette campagne de relevés nous avons utilisé la combinaison de deux méthodes de travail : à savoir le positionnement satellitaire et le relevé topographique à l'aide d'une station totale. Le matériel utilisé pour le système de localisation mondial est un récepteur bi-fréquences de précision centimétrique (Fig. 24) en temps réel grâce aux corrections Omnistar<sup>9</sup>. Ce système utilise les satellites GPS (Américain) et GLONASS (Russe) pour augmenter la qualité de la réception et donc la précision des mesures. Les coordonnées sont corrigées en temps réel via les informations envoyées par le satellite privé Omnistar (ce qui évite d'avoir sur le terrain deux récepteur GPS et remplace le post traitement par du temps réel, permettant ainsi une vérification immédiate des données sur le terrain). Pour le traitement topographique classique nous avons utilisé la station totale Leica TC803 de l'IFEAD (Fig. 25).

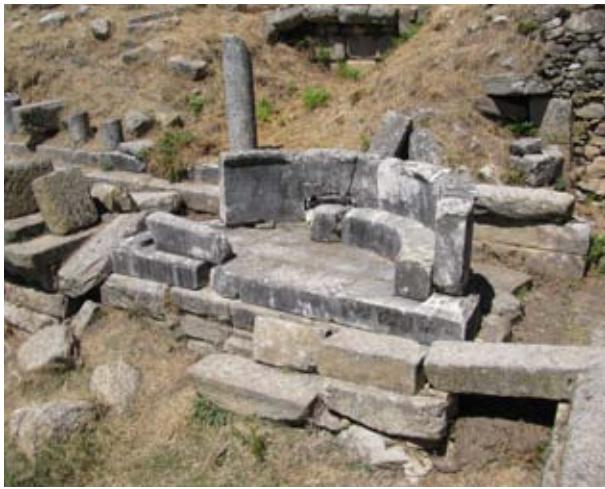
**Fig. 28 : Etat actuel de l'Exèdre de la terrasse du temple** (Photo : Fr. Tobin).

### **3.2. The *exedra* on the temple terrace (Fig. 28)** (par F. Tobin, université d'Uppsala)

The monument itself is semi-circular in shape, roughly 4 meters wide and 2 meters deep. It consists of a platform on which stands a curved back wall and a low bench. The *exedra* itself is made entirely of marble and stands on a rectangular base made of local gneiss. The northern edge of the base extends under the *euthynteria* of the North *Stoa*, suggesting that the construction of the *stoa* postdates the construction of the *exedra* (or at the very least the construction of the foundation of the *exedra*). This means that the stylobate of the *stoa* cannot date to the era of Maussollos.

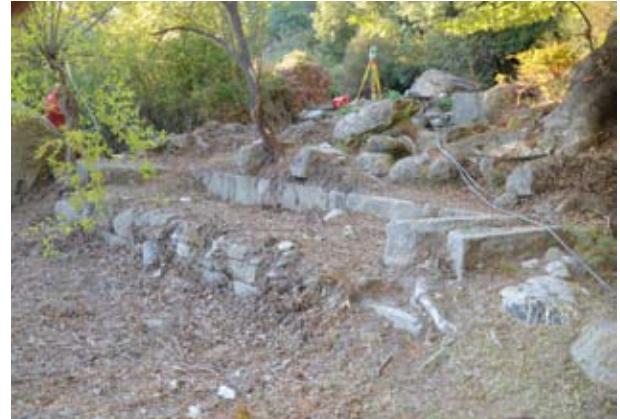
**Fig. 29 : La fontaine monumentale après nettoyage** (photo : O. Henry).

Suite à un important travail de nettoyage qui, cette année, a largement dépassé les limites du *temenos*, nous avons pu mettre au jour une structure jusqu'ici inconnue (Fig. 29). Pourtant située à proximité de la zone de travail, 110 m au Nord-Ouest du temple de Zeus, cette structure composée de larges blocs de gneiss offre un plan en *Pi* composé d'un mur orienté est-ouest de 7 m de long aux extrémités duquel on trouve deux murs de refend, probablement des *antes*, qui forment un retour de 1,60 m. Bien que le bâtiment soit très arasé il présente encore une élévation de plus de 1 m. La technique de construction semble clairement hellénistique avec un arrangement du parement en carreau et boutisse. De nombreux blocs d'architecture sont encore visibles dans les murs de terrasses situées sous le bâtiment, on repère

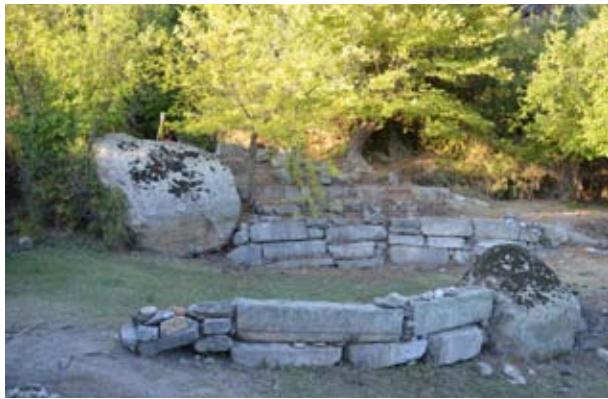
**Fig. 30 : Blocs architecturaux de la fontaine monumentale dans les murs de terrasse alentours (photo : O. Henry).**

notamment deux futs de colonne ainsi que de très grandes architraves (Fig. 30).

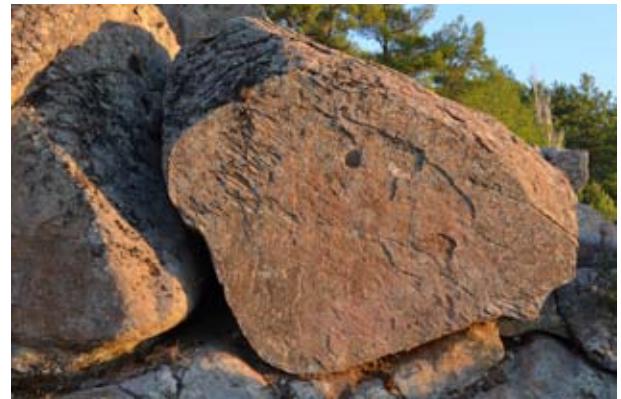
**Fig. 31 : L'inscription rupestre (photo : O. Henry).**

Une autre découverte fortuite a eu lieu cette année. Il s'agit cette fois d'une courte inscription gravée sur une face rocheuse, à 2,15 m au-dessus du sol. Le texte est simple, il présente un nom propre ANΔPONIK. D'après les témoignages des locaux, une première ligne de texte, comportant au moins un *oméga* était visible il y a encore quelques années. Malheureusement la partie haute de la face rocheuse portant l'inscription est aujourd'hui très érodée et il est impossible d'y lire quoique ce soit. On note cependant la présence, plus haut, d'une petite cavité qui pourrait correspondre à un trou de poutre (mais il semble bien étroit).

alentours. Ces dernières offrent de très nombreux affleurements rocheux qui portent presque tous des traces d'extraction de pierre. S'agit-il d'une zone de carrière privée dont le propriétaire a voulu marquer la possession ? On précisera que la taille de l'inscription est impressionnante puisqu'elle mesure 2,18 m de long avec des lettres de 17 à 20 cm de haut (*l'omicron* est plus petit, 13 cm). La forme des lettres (*alpha* à haste brisée, *rho* effilé et petite taille de *l'omicron*) semble indiquer une date autour de la fin de la période hellénistique.

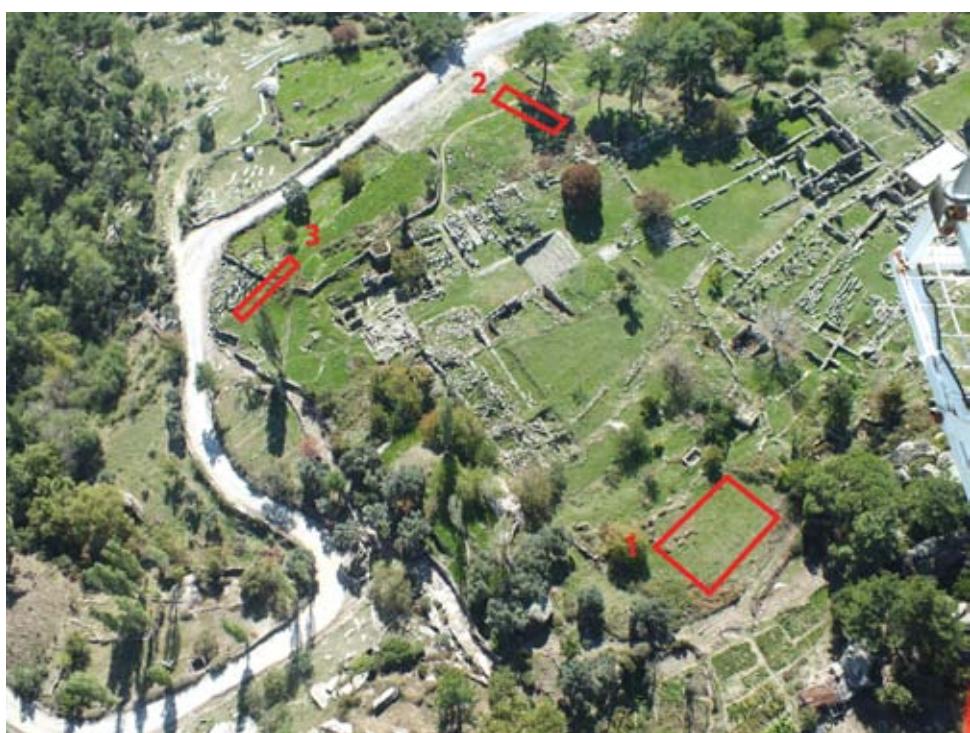
**Fig. 32 : Localisation des trois zones balayées par les prospections géophysiques (photo : O. Henry).**

Cette année une campagne de recherche géophysique a été menée dans trois secteurs du sanctuaire (Fig. 32). Le premier concerne l'angle nord-est du *temenos*, le second la partie sud-ouest du sanctuaire, dans l'angle formé à l'Ouest par le long mur de terrasse sud, le dernier est situé au Nord et au contact du bâtiment hypostyle.

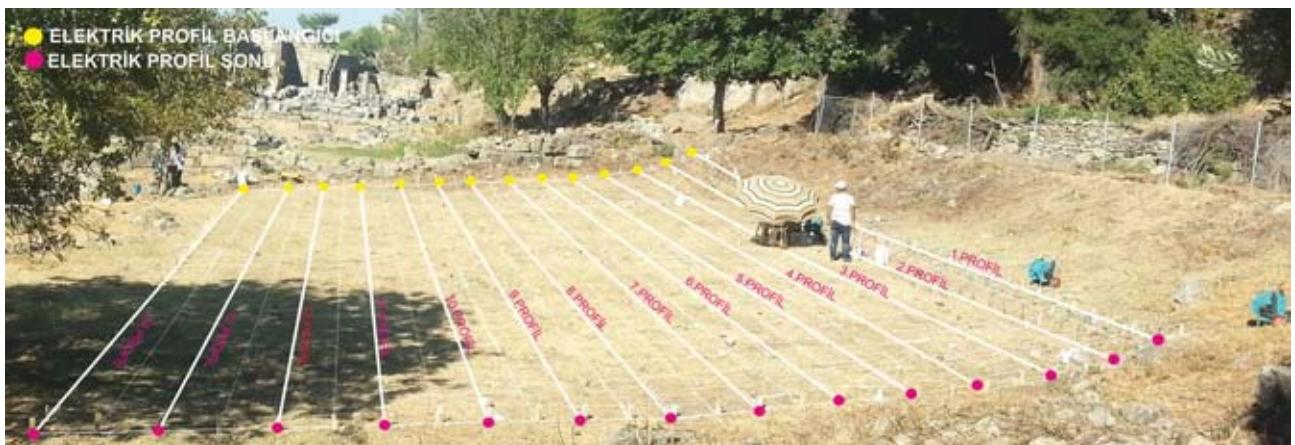
**Fig. 33 : Mise en place du système d'analyse en zone 1 (C. Karavul).**

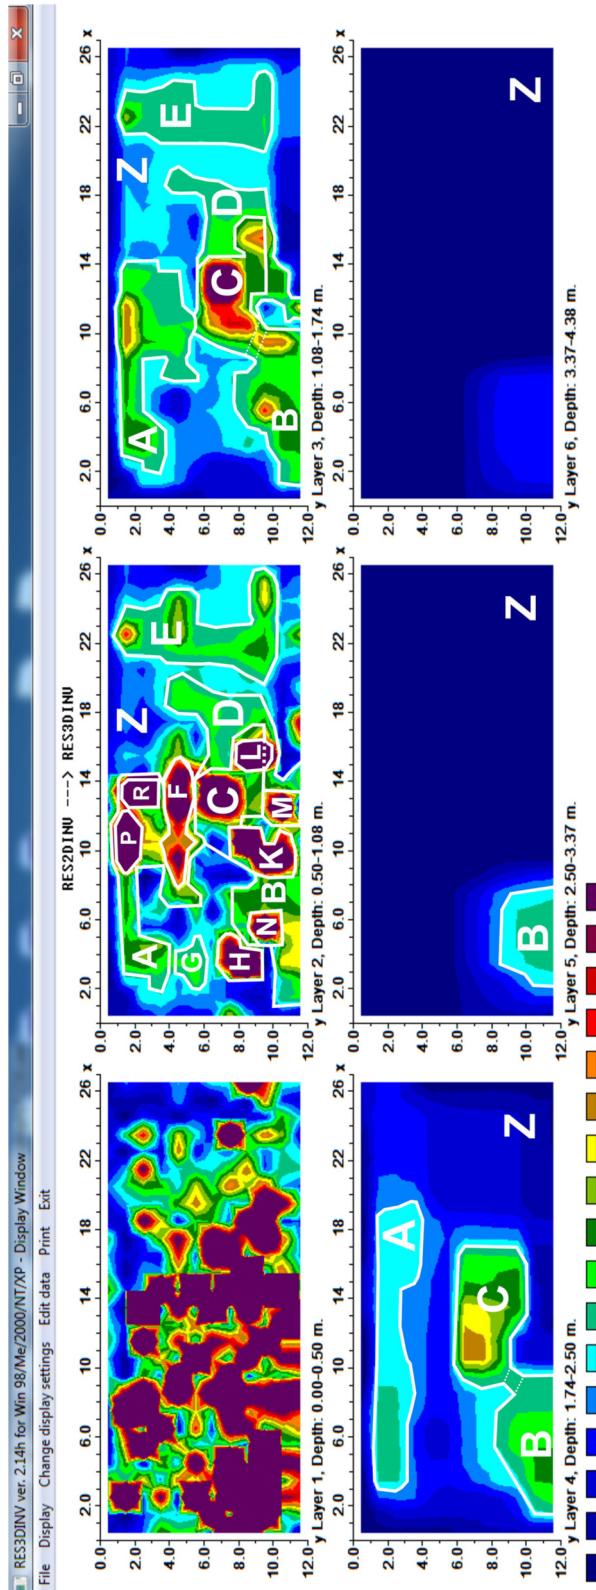
Fig. 34 : Résultat des coupes géo-électriques en zone 1 (C. Karavul).

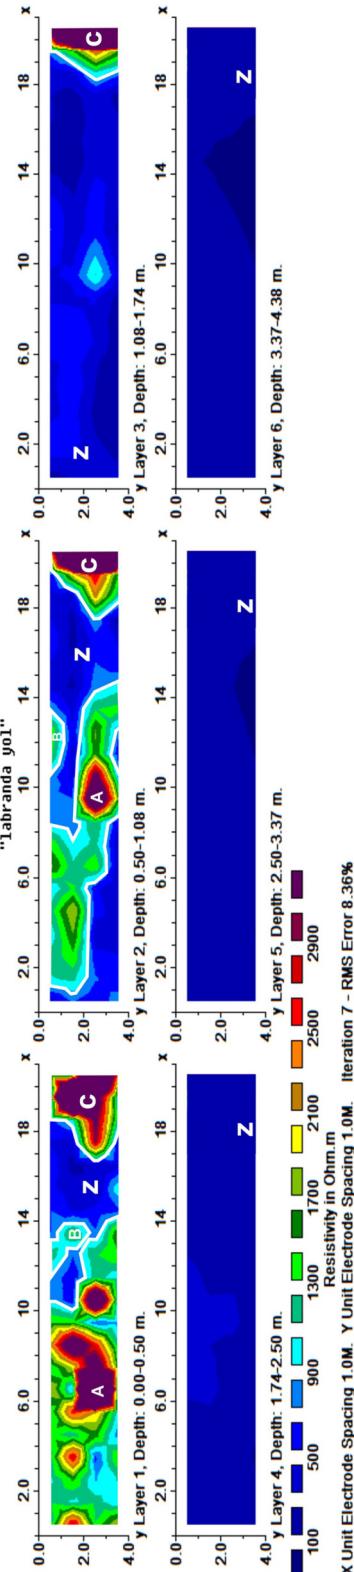
Fig. 35 : Résultat des coupes géo-électriques en zone 2 (C. Karavul).

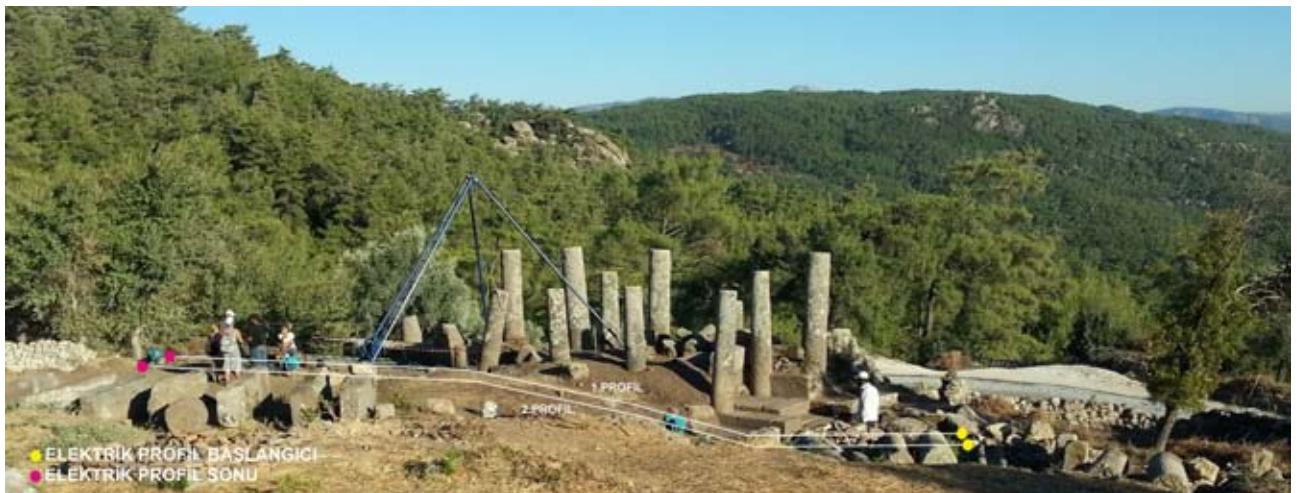
Fig. 36 : Mise en place du système d'analyse en zone 3 (C. Karavul).

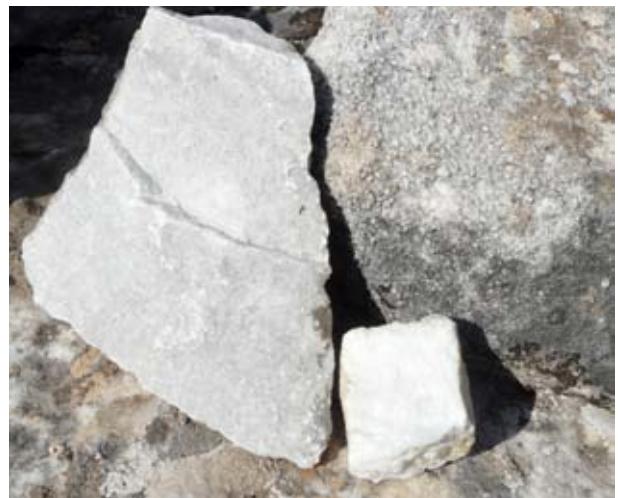
**Fig. 38 : The three different kind of marbles at Labraunda** (photo : A. Freccero).

There are at least three kinds of marble at the Sanctuary of Labraunda (Fig. 38). According to ancient writers, such as Strabo, Mylasa was known for its many buildings of white marble, and he suggests that such marble might have been used at Labraunda too<sup>13</sup>. Could three different kinds of marble have been quarried at Sodradağ? Yes, it is possible, because diverse quarries in a mountain may provide different kinds of stones. Another possibility is that some blocks were brought from Sodra and other pieces from yet unknown caves, and that trading routs are liked to periods in time. There is also the option that one type of marble was preferred for sculpture and finely cut inscriptions and architectonic elements while another quality was used for columns, bases and anta blocks, and these qualities may have different origins. I assume that the Karian kings, in order to impress the people and demonstrate their power would choose what was considered the very best at the time, rather than choosing the product nearest available only because the transport was easier and cheaper. Was Mylasa marble known as the best, was it considered as superior to *e.g.* the famous marble from Herakleia?

Ocular observations during surveying and conservation in 2011-2012 indicated there were at least three kinds of marble at the site. Most characteristic was a large-grained white marble which often had veins of large calcite crystals. The marble used was identified at columns and architraves of Hekatomnid buildings. The second distinctive type was a fine-grained white marble, used for the Corinthian capitals of the so called North Stoa of the Roman period. The third marble type was pale grey with fine grains, identified at blocks that were not noted in the conservation plan. There are also some less distinct marbles which are *e.g.* white with grey veins or white with medium sized grains. These may be variations of those mentioned above or they are additional types. In order to see if there was any link between Sodra and Labraunda, four marble samples were sent for analyses to CNR/ICVBC in Florence in 2011<sup>15</sup>. Two of these were obtained at Labraunda, one from quarries at Sodra and an additional white piece of marble obtained at a modern quarry close to Stratonikeia. All samples were fallen pieces on the ground, and therefore not indicative of any period; the only reason was to understand if there was any connection between the marbles.

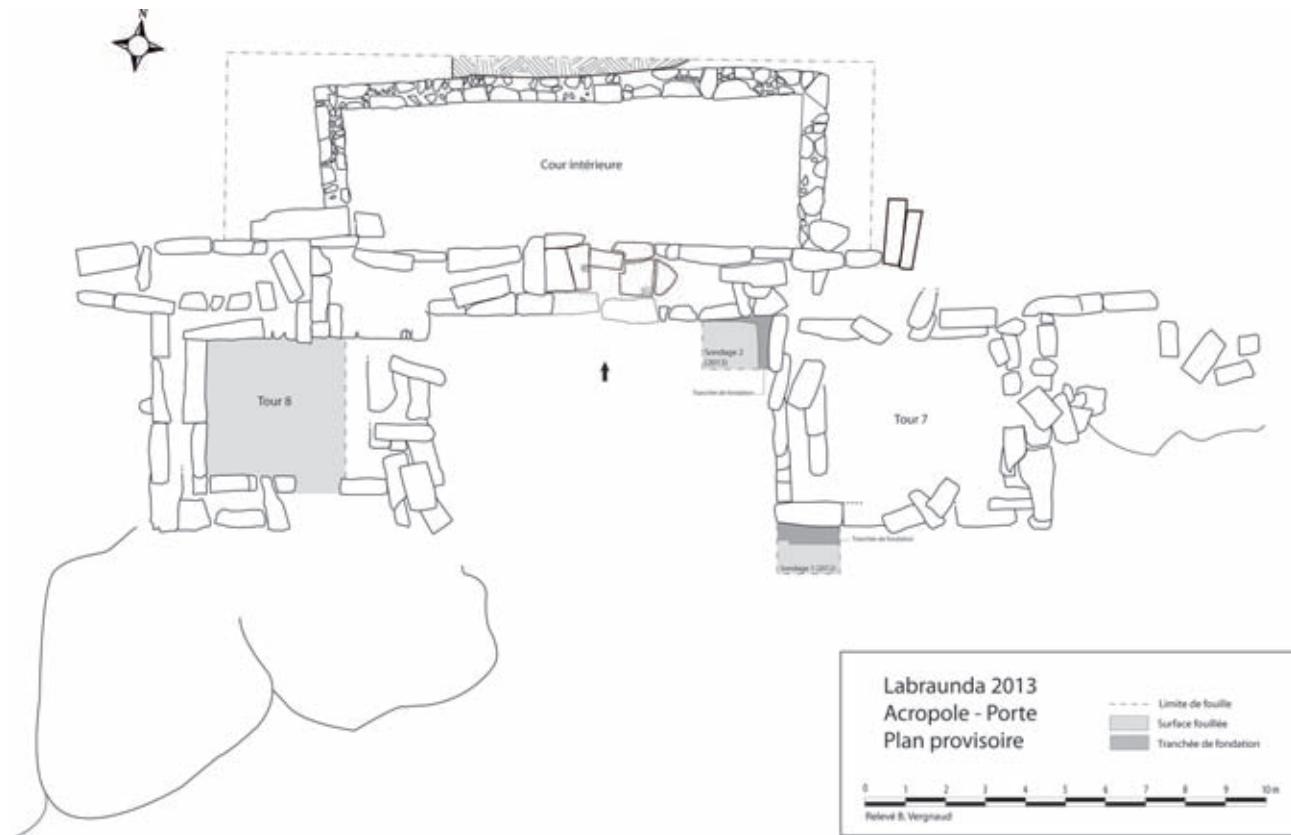
**Fig. 41 : Plan provisoire de la porte (B. Vergnaud).**

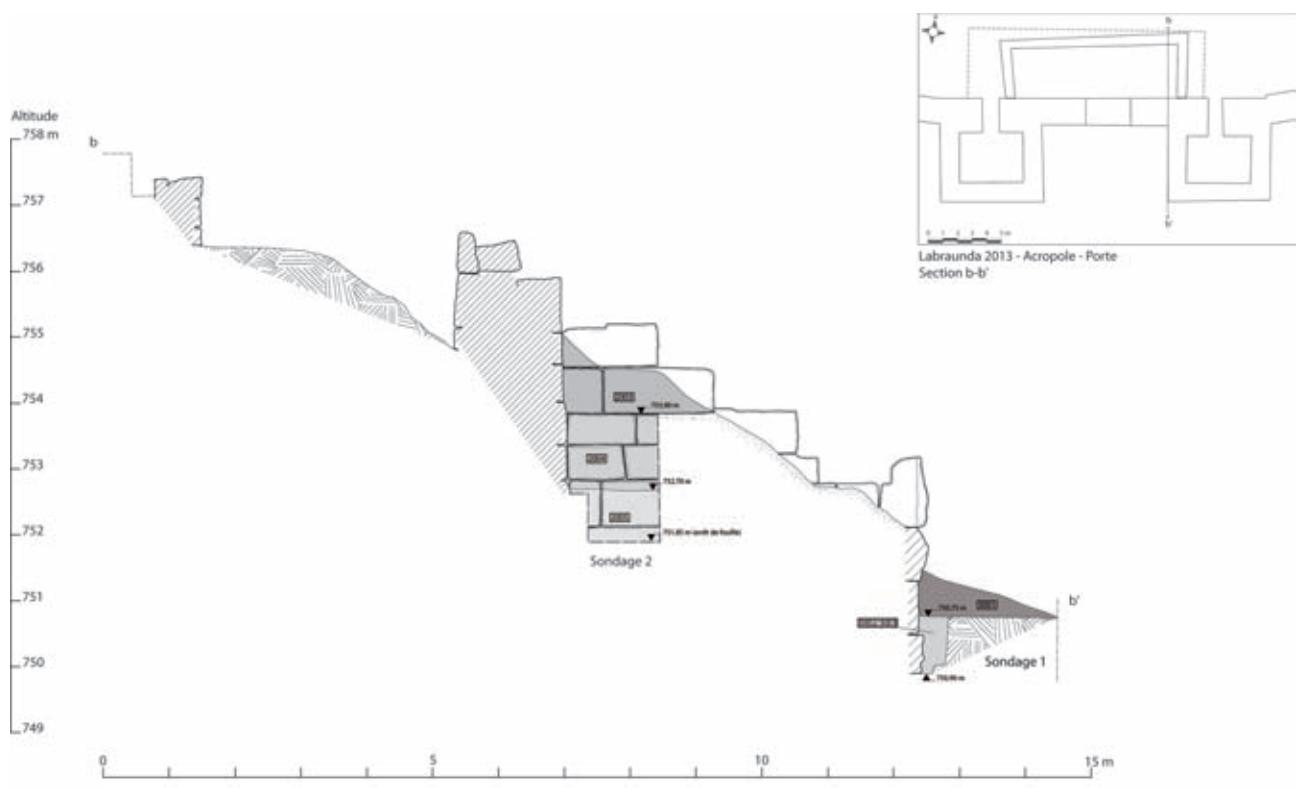
**Fig. 42 : Section b-b'** (B. Vergnaud).

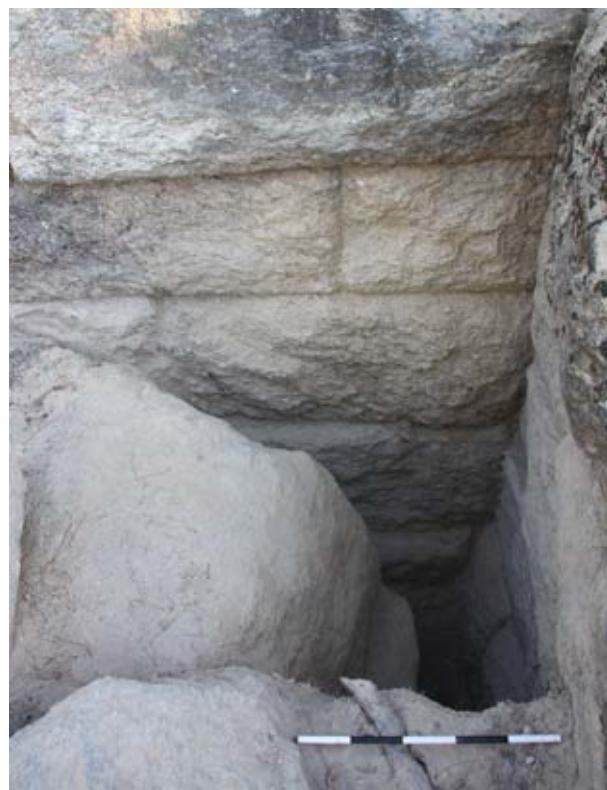
**Fig. 43 : Tour 7. Sondage 2.** (B. Vergnaud).

Afin d'obtenir des précisions chronologiques sur la construction du système de défense et de déterminer les potentielles phases de modification, nous avons réalisé deux sondages contre les parements externes de la tour 7 (Fig. 42). En 2012, un premier sondage a été réalisé à l'angle sud-ouest de la tour. Il n'a pas livré de matériel datable. En 2013, un second sondage a été réalisé à l'angle de la tour 7 et du mur d'entrée (Fig. 43). Ces deux sondages nous ont permis d'obtenir une image claire des méthodes de fondations utilisées dans le secteur. En effet, le rocher a été creusé en profondeur avant la mise en

place des murs afin de leur offrir un puissant ancrage en raison de la déclivité importante du terrain. La tour 7, fondée de la sorte, servait donc de contrefort au mur de fortification. Le matériel du second sondage n'est pas très abondant, mais son contexte est bien assuré et son identification permet de discuter la chronologie établie<sup>19</sup>. Deux couches (2004-2005) composent le remplissage de cette tranchée de fondation qui est scellée par une couche d'abandon (2003) qui ne contenait aucun matériel postérieur à l'époque hellénistique. La couche supérieure (2004) a notamment livré deux fragments d'un bol à bord incurvé datable de l'époque hellénistique et plus précisément du III<sup>e</sup> s. av. J.-C. (Fig. 44)<sup>20</sup>. Le matériel de la couche 2005 est composé d'un fragment de *tégula* semblable à celui découvert par Lars Karlsson au sommet de l'acropole (AKW09-11) et daté de l'époque hékatomnide<sup>21</sup>. Cependant, la céramique pourrait être plus tardive et appartenir à la période suivante. Les découvertes effectuées dans le remplissage de la tranchée de fondation supposent que la forteresse pourrait avoir été en partie remaniée au cours de l'époque hellénistique (Fig. 45)<sup>22</sup>.

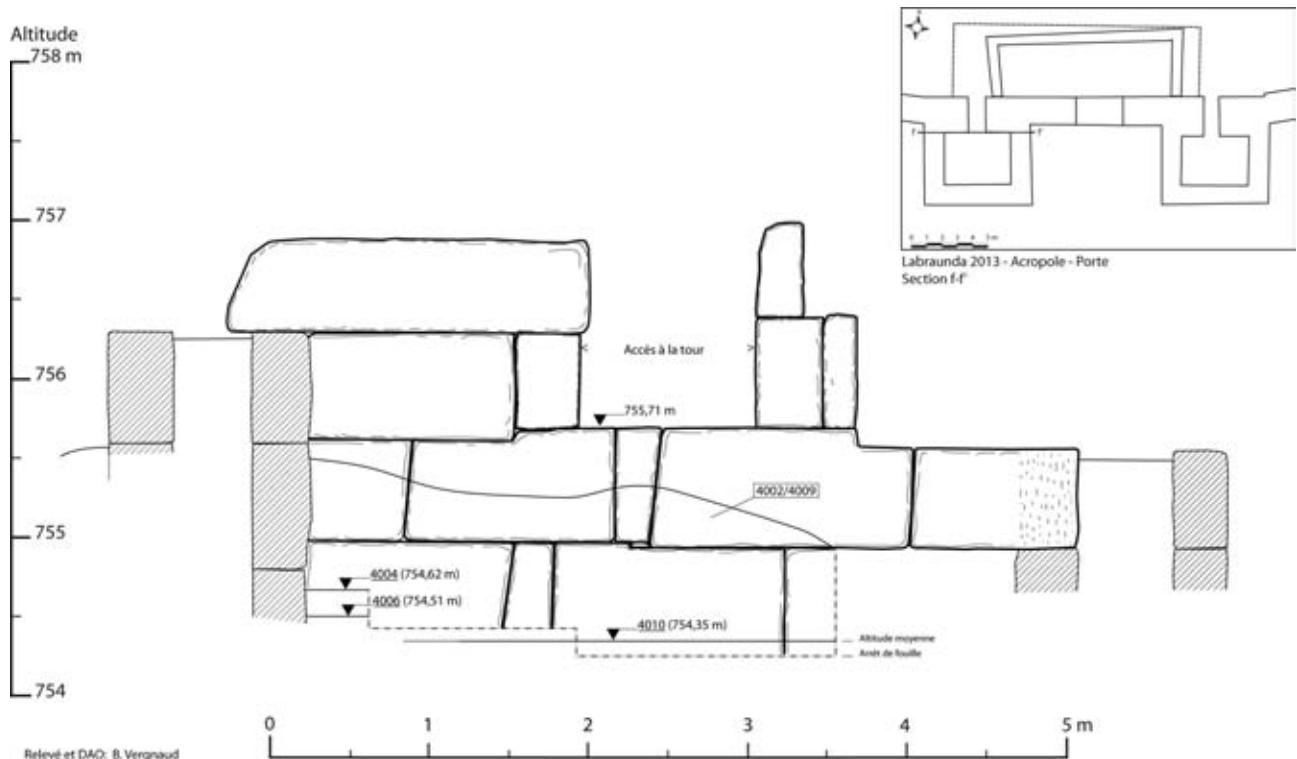
**Fig. 47 : Tour 8. Section f-f' (B. Vergnaud).**

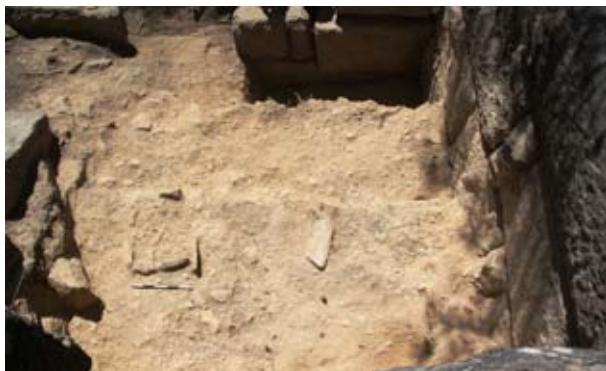
**Fig. 48 : Tour 8. 4010 et foyer 4012**  
(B. Vergnaud).

d'1 m de large. L'essentiel des travaux a porté sur la surface intérieure de la tour. Les fouilles stratigraphiques ont conduit à la mise au jour de plusieurs niveaux de sols en terre compactée (4004-4006-4003-4007-4010) qui ont été très altérés par l'effondrement de la construction. S'il a été nécessaire de les distinguer en raison de leur couleur, texture et altitude, ils paraissent appartenir au même horizon chronologique au regard du matériel qui leur est associé. Cette accumulation s'explique très probablement par les opérations de nivelage réalisées au cours d'une période assez courte. Ces niveaux de circulation étaient scellés par une épaisse couche de destruction (4002-4009) qui contenait des blocs de pierre de taille diverse et à l'intérieur de laquelle aucun matériel postérieur à l'époque hellénistique n'a été découvert. Parmi les niveaux de sols identifiés, seul le niveau 4010 a pu être mis au jour sur une grande surface (Fig. 48)<sup>24</sup>. Celui-ci reposait sur une couche de remblai d'1 m d'épaisseur composée de petites pierres et de terre (4011) installée directement sur le rocher naturel préalablement aplani. Un sondage a été réalisé dans ce remblai à l'angle sud-ouest de la tour mais il n'a livré aucun matériel.

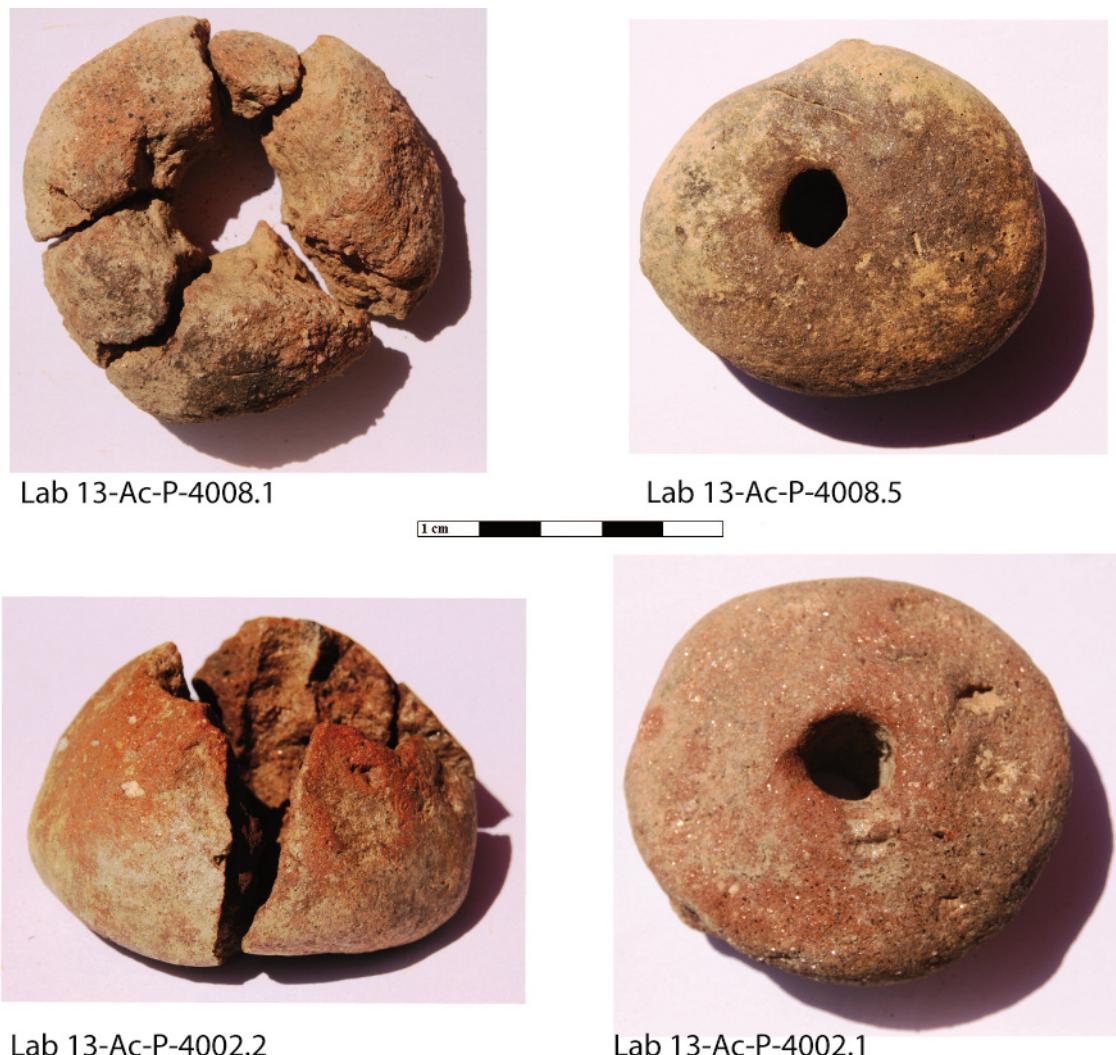
**Fig. 54 : Tour 8. Pesons (B. Vergnaud).**

Les autres découvertes sont d'un intérêt limité pour les questions de datation mais nous renseignent sur les activités qui avaient lieu à l'intérieur de la tour. Un foyer en pierre de forme rectangulaire (0,60 x 0,68 m), comparable à ceux mis au jour à Tepesar Kale et à Kepez Kule<sup>30</sup>, était associé au sol 4010 et peut être mis en relation avec les activités culinaires (Fig. 48). Plusieurs fragments métalliques ont également été découverts à proximité du foyer, mais puisqu'aucune scorie n'a été retrouvée, l'hypothèse actuelle est que ces éléments appartenaient aux huissières des portes et des volets de la tour. La découverte la plus inattendue est celle de 4 pesons

en terre cuite (Fig. 54). Trois d'entre eux présentent une forme ovoïde aplatie et l'un d'entre eux est tronconique. Cette découverte est inhabituelle. Aucune autre pièce de ce type n'a été découverte lors des fouilles précédentes sur l'acropole ou dans les autres tours du voisinage. Plus généralement, pesons et fusaïoles se rencontrent rarement dans un contexte militaire<sup>31</sup>. Ces pesons révèlent l'existence d'activités artisanales liées au tissage et leur présence renforce l'idée selon laquelle la tour était un lieu de vie.

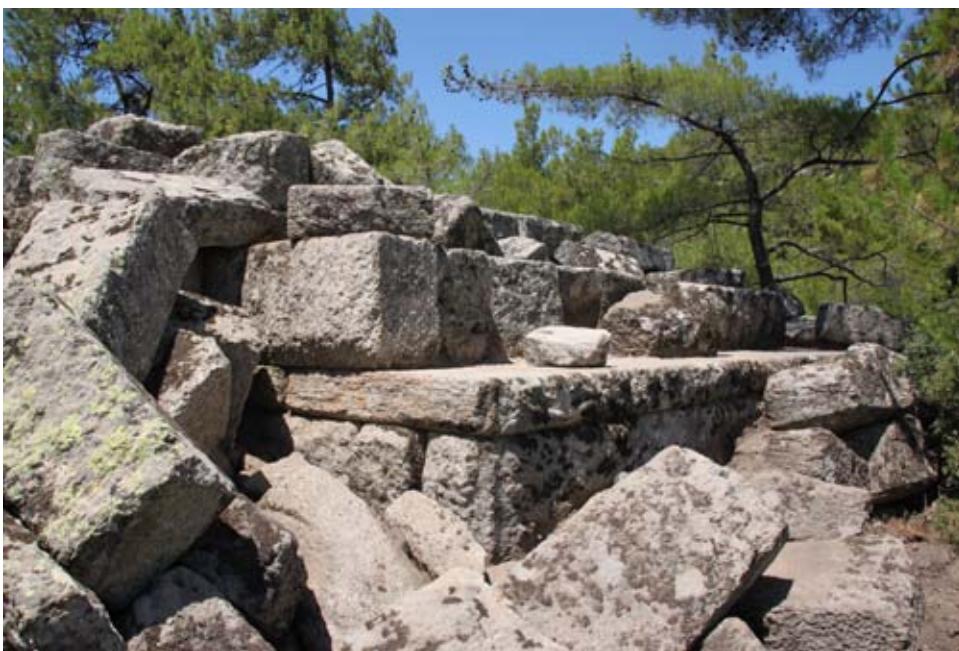
**Fig. 56 : Tour pentagonale. Angle sud-est** (B. Vergnaud).

est le premier indice. Les murs se composent en effet d'une alternance, à chaque assise, de carreaux et de panneresses (Fig. 56-57). Cette technique n'est pas employée dans l'architecture défensive hékatomnide où la pratique courante est d'alterner carreaux et boutisses. En revanche, elle apparaît de façon assez récurrente dans les constructions de l'époque suivante aussi bien dans les bâtiments civils, religieux que militaires<sup>39</sup>. La datation de cette tour est renforcée par comparaison avec les tours de même plan connues en Carie (Hyllarima, Harpasa), dans les régions voisines (Oinoanda, Samos) ou plus lointaines (Gadara)<sup>40</sup>. Bien que pour l'essentiel la datation de ces ouvrages repose sur des critères historiques, toutes sont datées au plus tôt à la toute fin du IV<sup>e</sup> s. av. J.-C. et leur apparition est généralement mise en relation avec le développement de la guerre de siège conséquent à la conquête macédonienne. L'étude de cette tour sera poursuivie dans la campagne suivante.

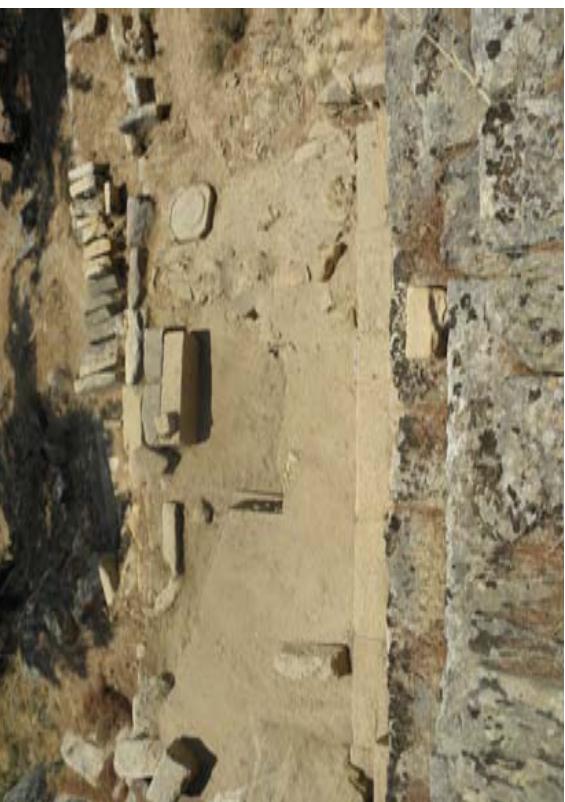
Fig. 62 : Emplacement du sondage au centre du bâtiment en *Pi*  
(photo : M. Cormier).

Le sondage a été positionné au centre de la structure, au contact du niveau de blocs sur lequel nous nous étions arrêtés l'année dernière (Fig. 62). Mesurant 2,80 m de large, nous avons atteint la roche sur la quasi-totalité du sondage. Il apparaît

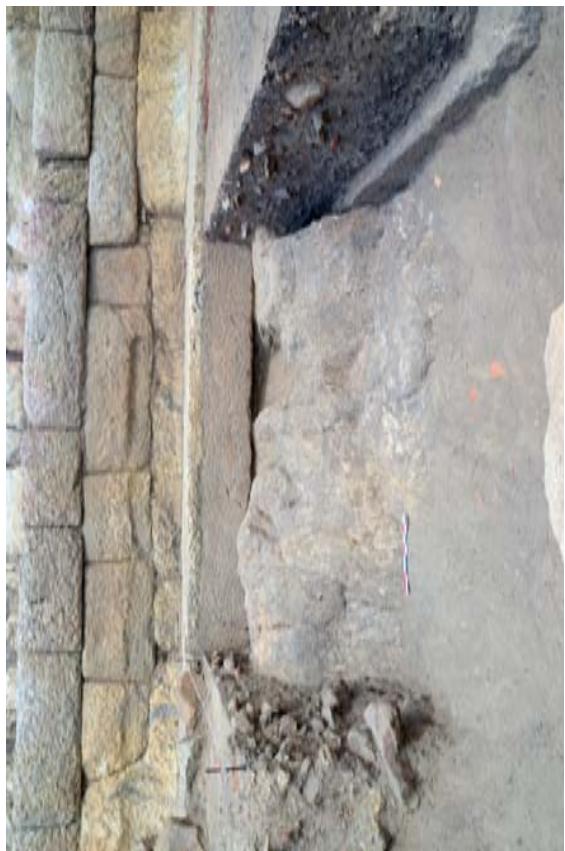
Fig. 63 : Le sondage en fin de fouille  
(photo : M. Cormier).

que les blocs soutenant les banquettes du bâtiment en *Pi* sont directement posés sur le rocher qui a été entaillé de manière à offrir une base de fondation parfaitement horizontale à l'assise de blocs. On repère trois niveaux stratigraphiques dans le remplissage des structures de fondation (Fig. 63). Le niveau supérieur, correspondant au niveau du sol du bâtiment en *Pi* présente un large nombre de fragments de tuile et assez peu de matériel céramique. Une monnaie de Rhodes, trouvée à la base de ce niveau, daterait l'ensemble de la fin du III<sup>e</sup> s. - début du II<sup>e</sup> s. av. J.-C. (Fig. 64)<sup>43</sup>. La couche intermédiaire est relativement fine. Elle est plus meuble et argileuse que la précédente. On note une forte concentration de tuiles et de céramiques dans la partie nord-est du sondage. La dernière couche, qui correspond probablement à la mise en place du bâtiment en *Pi*, repose sur le rocher. Elle diffère radicalement des autres. Il s'agit d'une couche très meuble, gris/noir, comportant un important matériel céramique souvent brûlé et des végétaux (graines) carbonisés. Une monnaie mise au jour dans la partie sud-ouest du sondage, entre le rocher et cette couche, daterait ce niveau de la fin du IV<sup>e</sup> s. av. J.-C. (Fig. 65)<sup>44</sup>.

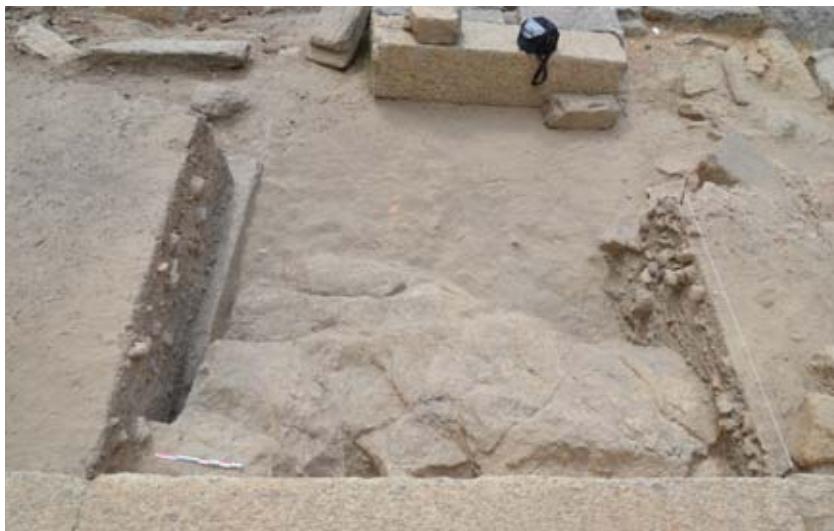
**Fig. 66 : Le sondage vu du Nord, à gauche on repère l'extrémité d'une structure antérieure**  
(photo : O. Henry).

Au fond du sondage, 72 cm sous le niveau du sol appareillé de la structure en *Pi* et sous la limite est de la tranchée, on a mis au jour ce qui semble apparaître comme étant une phase de construction antérieure. Il s'agit d'un mur axé nord-sud (perpendiculairement à l'axe du bâtiment en *Pi*) composé d'un large blocs de gneiss entièrement inséré dans le rocher (Fig. 66). Des marques de taille sur la face d'attente de ce bloc indiquent clairement la présence originelle d'une assise supérieure perpendiculaire. Dans l'état actuel du sondage, qu'il faudra poursuivre vers le Sud et l'Est, nous n'avons aucune indication concernant la date ou la fonction de cette construction antérieure. Celle-ci doit dater d'une période antérieure à la conquête macédonienne. Cette découverte vient confirmer l'hypothèse que nous formulions l'année dernière après l'analyse des structures de la pente sous la tombe monumentale, tout en rebâissant la date. Il semble donc qu'un large remaniement ait été opéré vers la fin du III<sup>e</sup> s. av. J.-C. dans la zone, entre le podium de la tombe et la terrasse du temple, probablement à l'occasion de la réutilisation de la tombe. Ce réaménagement a vu la construction du grand bâtiment en *Pi* (qui oblitera un bâtiment plus ancien, démonté pour l'occasion) et probablement par la même occasion la série de murs de terrasse permettant de relier physiquement la terrasse du temple à la tombe monumentale.
