**ANATOLIA ANTIQUA  
ESKİ ANADOLU**

Olivier HENRY\*

## LA MISSION LABRAUNDA 2013 – RAPPORT PRELIMINAIRE

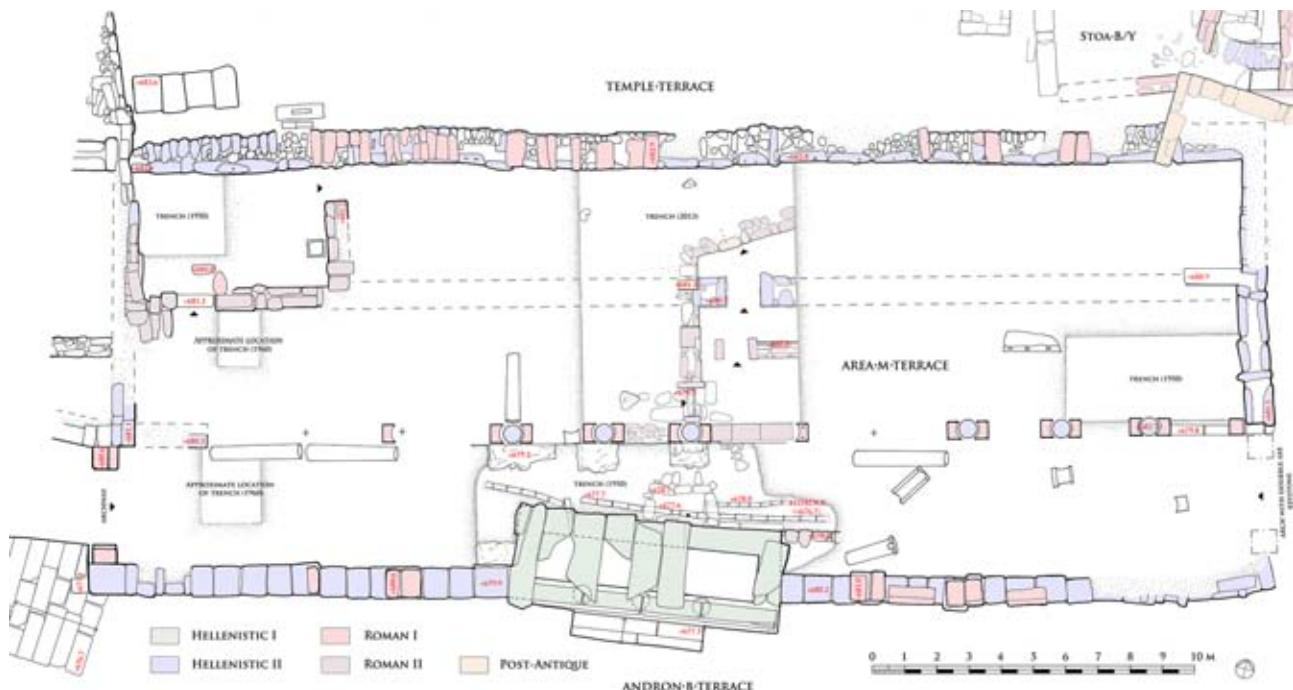
**Fig. 68 : Actual state plan of Terrace M (J. Blid & R. Hedlund).**

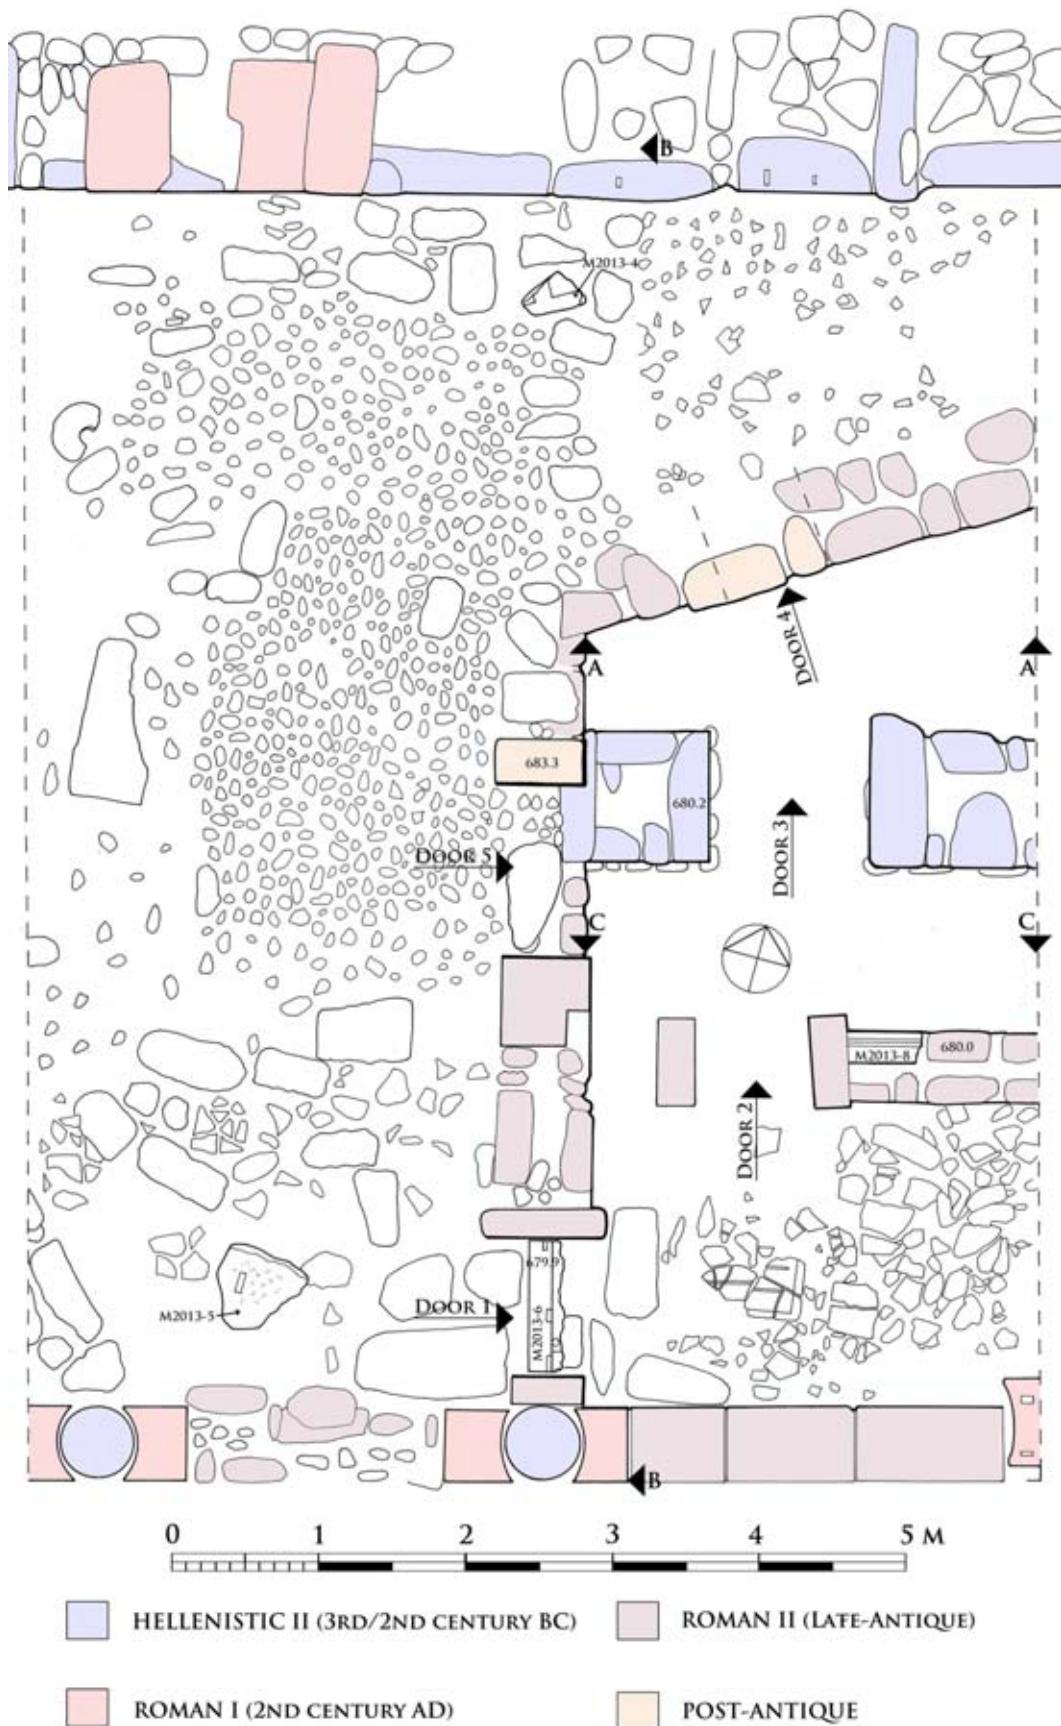
Fig. 69 : Actual state plan of Trench M1 (J. Blid & R. Hedlund).

It seems that the dwelling of Str. 1 was entered from Door 5 (see fig. 69). It should, however, be noted that this may originally have been a window of the subsequent structure associated with Str. 3 & 3B. Nothing else remains of the architecture that may have been associated with Str. 1.

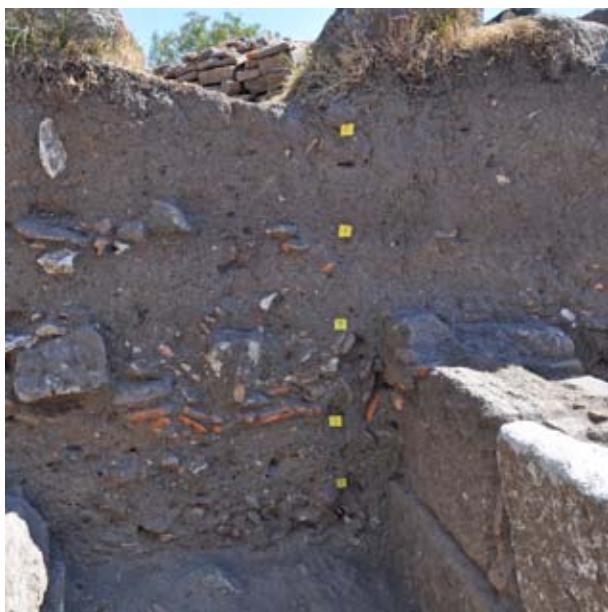
**Fig. 70 : Strata shown in the eastern section of Trench M1 (J. Blid & R. Hedlund).**

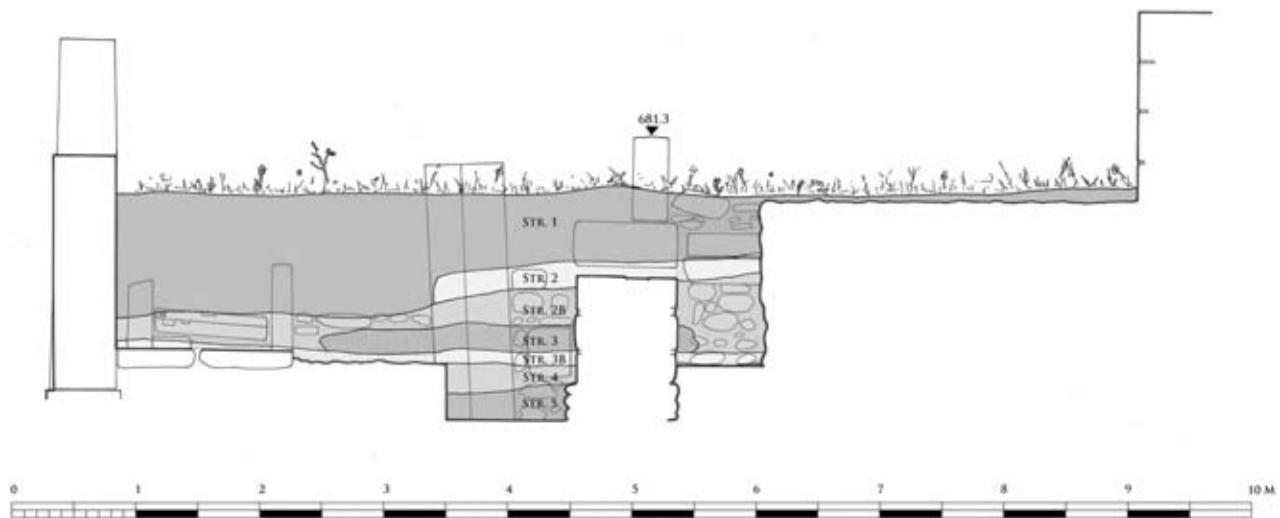
Fig. 71 : Section B-B with added stratigraphical references (J. Blid & R. Hedlund).

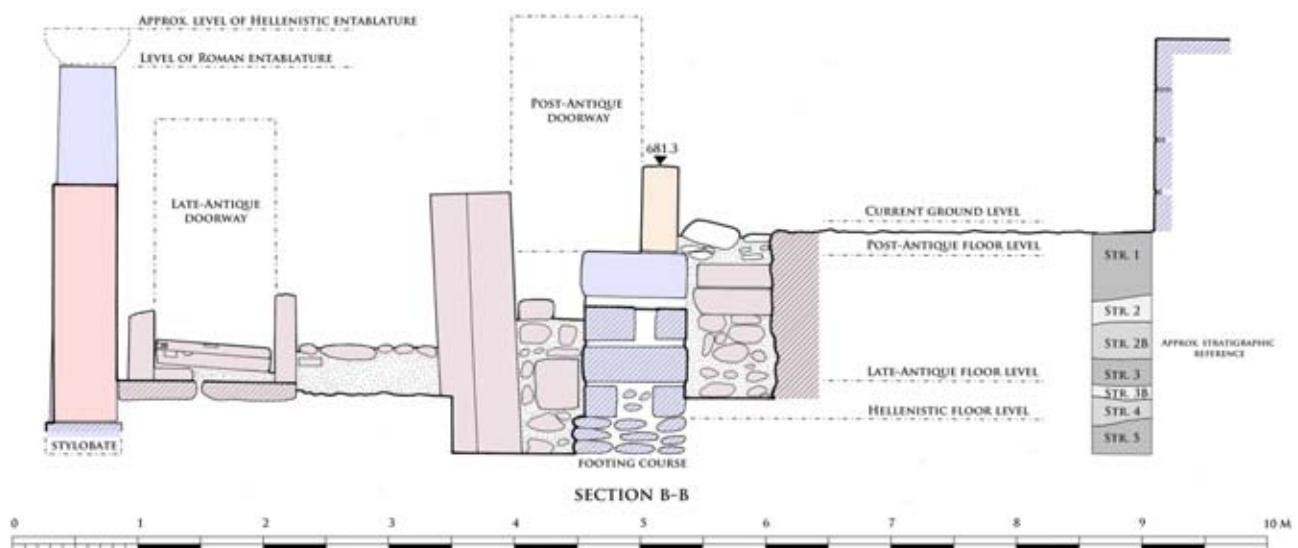
**Fig. 74 : Section B-B displaying the standing architectural remains with chronological references (J. Blid & R. Hedlund).**

The architectural remains of an earlier building complex emerged below Str. 2 & 2B. This partly protruded from the superposed occupation layers directly above. In fact, these remains actually constituted the foundations of the later occupation phase of Str. 2 & 2B. The walls associated with Str. 3 & 3B had been subdued by little alteration during the Middle Ages. Most notably, Door 4 was paved up; yet, apart from this, no new walls had been added, aside from the previously mentioned Door 5, which, in fact, may be a window from the Str. 3 & 3B phase (*cf.* Section B-B; Fig. 74).

The Terrace M excavations of 2013 support our previous interpretation that Building M was originally built as a two-aisled *stoa* in the Hellenistic period (Str. 5, Fig. 78, see also Fig. 74). Yet, there were older, Classical walls (probably 5<sup>th</sup> century) of unknown condition on site at that time. The Doric two-aisled *stoa*, which was probably built in the 3<sup>rd</sup> century B.C., may have been used for banqueting and storage of wine and foods, as suggested by organic and ceramic evidence. Building M was undoubtedly one of the largest buildings within the *temenos* at this time, also incorporating the Well-house on the *Andron* B Terrace further to the south (see Fig. 67-68). Str. 5 also exhibits the largest quantities of pottery, which, in our opinion, pinpoints the importance and vast activity at this particular terrace in the Hellenistic period.

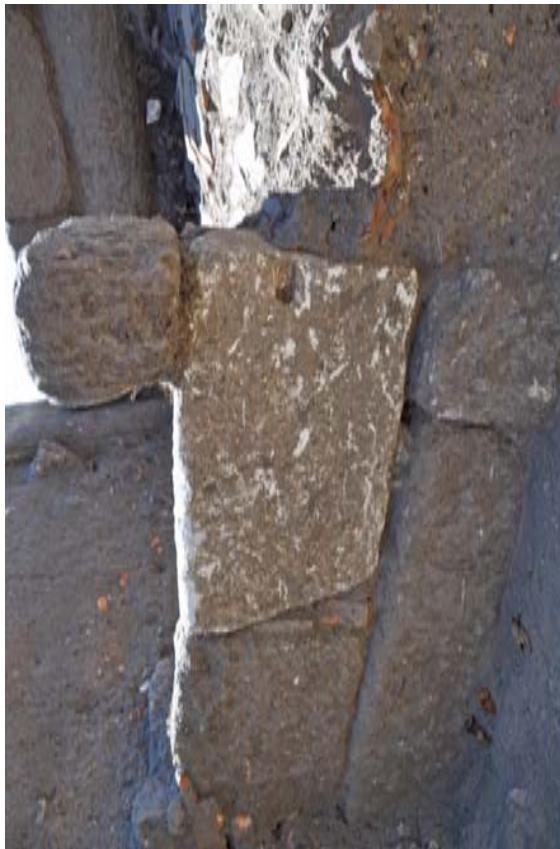
Fig. 75 : The collapsed roof-layer, Str. 3. Door 1 is seen at the top of the photograph (J. Blid & R. Hedlund).

In the SW part of the trench, we find what seems to be the main entrance of the late-antique complex, Door 1. The threshold is made from a reused marble block exhibiting clear remains of clamp holes (Fig. 75). To the west of this doorway are the remains of a marble pavement, also made from marble *spolia*. This area may have been an open courtyard in front of Door 1. Above the marble pavement of the courtyard, a layer of *ca.* 0.15 m fragments of roof tiles, smaller stones, and marble fragments (collapse layer) were removed. To the east of the threshold, very few finds were found on the equivalent level; those that were found were mostly roof tiles.

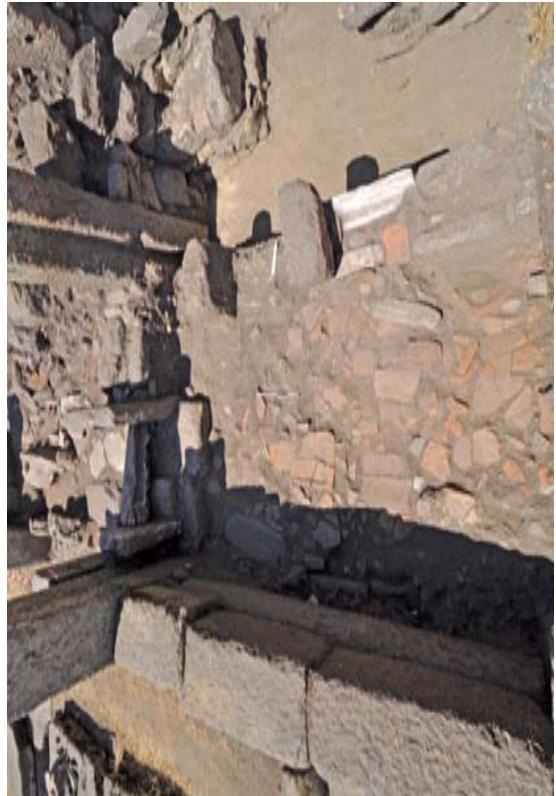
Fig. 76 : Late-antique spolia wall of Str. 3 (4<sup>th</sup> century A.D.) resting on the earliest recorded wall of Trench M1 (5<sup>th</sup> century B.C.) (J. Blid & R. Hedlund).

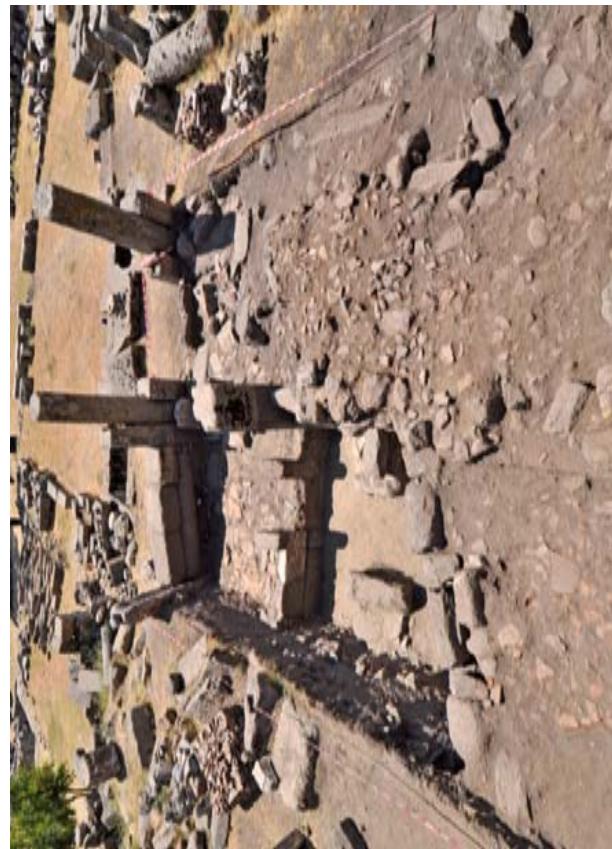
Fig. 77 : The centre wall of the Hellenistic stoa seen in the middle of the photograph (J. Blid & R. Hedlund).

centre wall also indicate that its surface was smoothened with stucco. Given that the mortar remains were found also on the top section of the footing course (which, presumably, would have been slightly buried in the Roman period), we suggest that the treatment of the gneiss façade may be original Hellenistic.

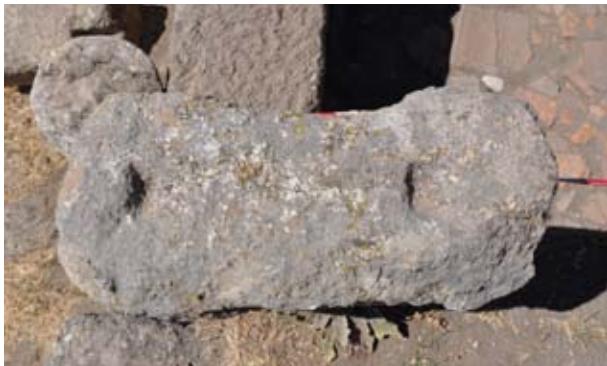
**Fig. 79 : Upper side of Roman gneiss supports (with dowel holes) used to consolidate the Hellenistic colonnade at the construction of the 2<sup>nd</sup>-century A.D. superstructure**  
(J. Blid & R. Hedlund).

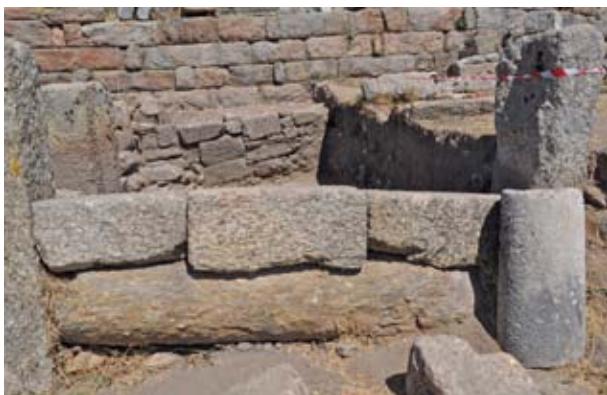
**Fig. 80 : Late-antique wall made from blocking the intercolumniation of the Hellenistic (and Roman Imperial) phase of Building M**  
(J. Blid & R. Hedlund).

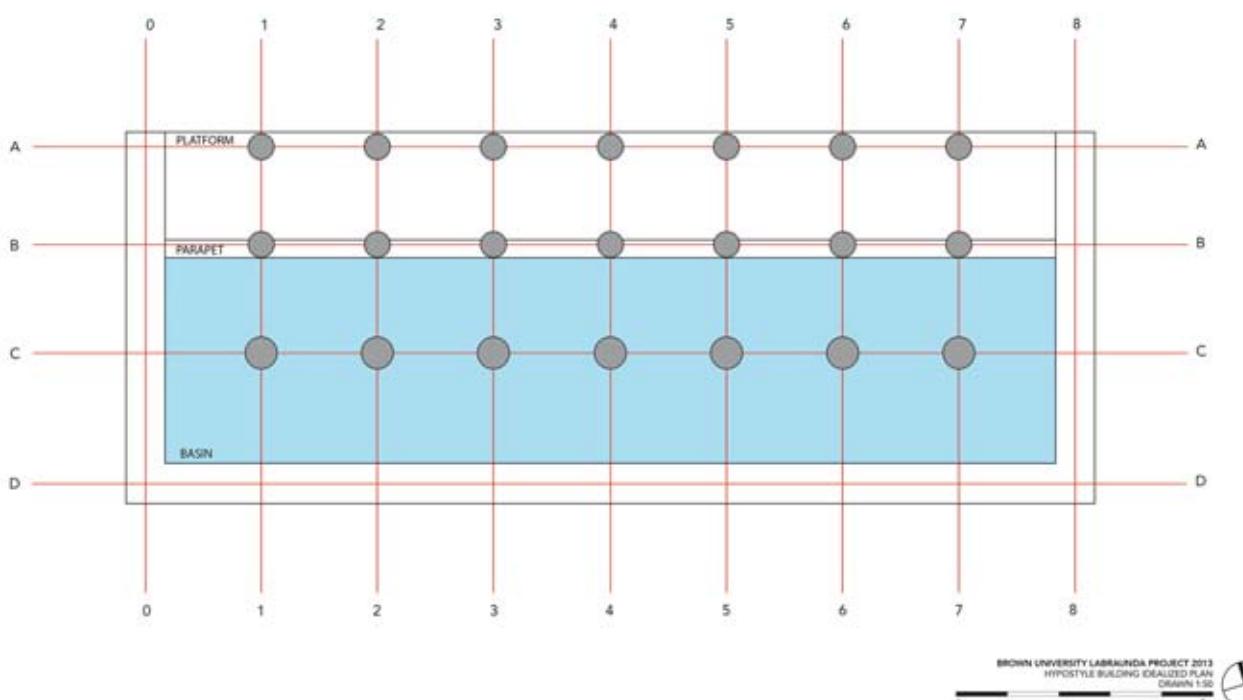
**Fig. 83 : Schematic plan of the HB showing column grid, platform, parapet, and basin (credit: BULP).**

The **HB** is made entirely out of gneiss (covered partly in hydraulic plaster and tile). As exposed until now, it is approximately 20 m long by 7.5 m wide (Fig. 81-87); since the structure's foundation is partly disarticulated and much of it still lies buried, more precise measurements will have to wait until the whole monument is excavated.

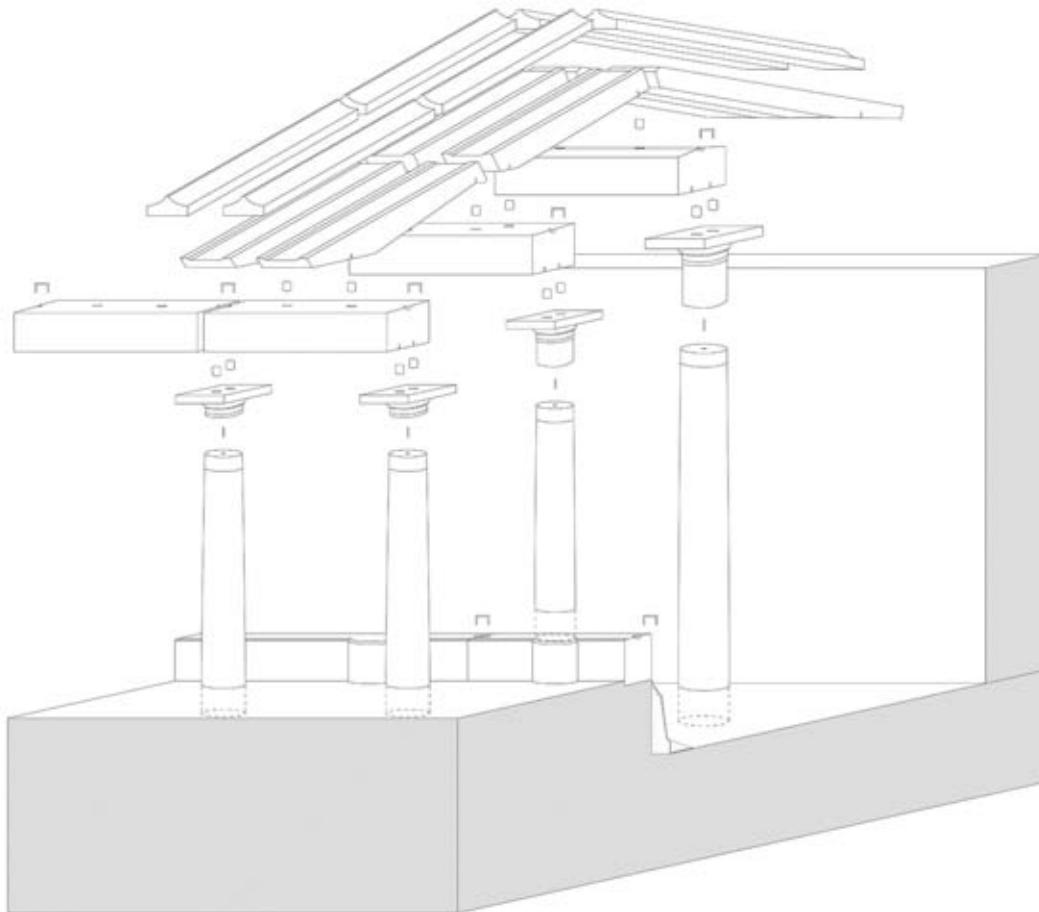
**Fig. 84 : Schematic exploded axonometric of HB showing most common block types, clamping, and doweling** (credit: BULP).

From an architectural perspective, the **HB**'s massive stone roof is specially interesting and peculiar. The gently pitched roof is covered by stone slabs that are as long as 3.10 m and can weigh up to 1.5 tons (see Fig. 84). The profiles of these slabs seem to imitate ceramic pan and cover tiles, but the blocks effectively act as a combination of tiles and rafters. These slabs are in some ways reminiscent of other massive stone tiles in Karia such as those found in the so-called 'temple' at Gerga.

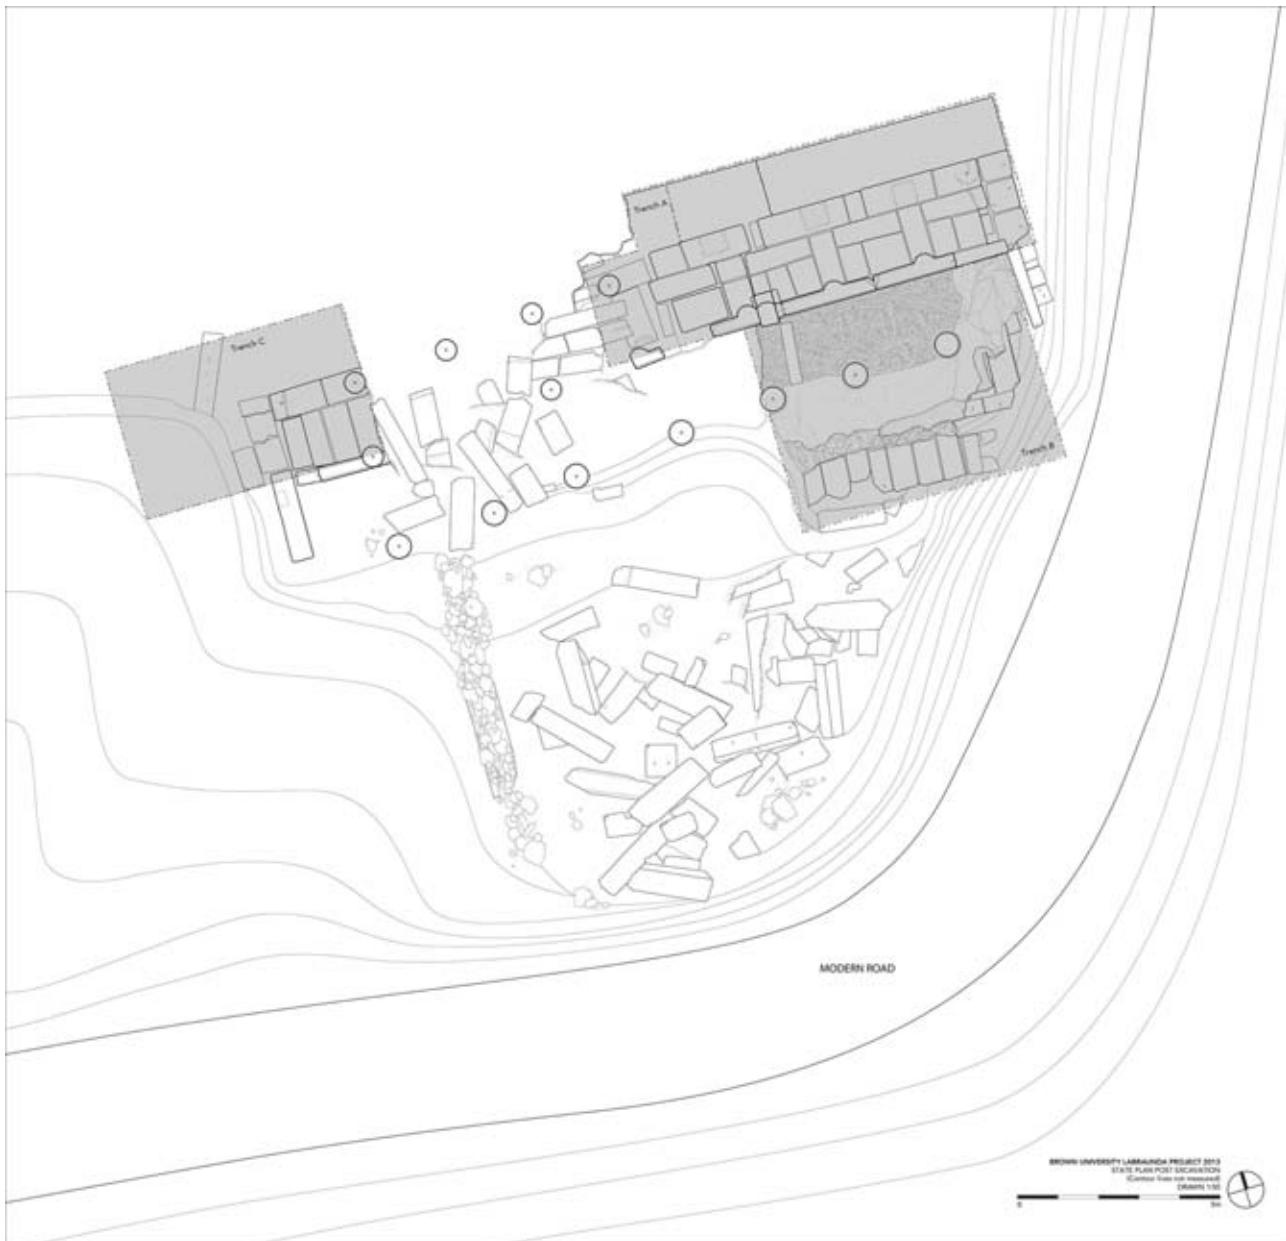
**Fig. 85 : State plan post excavation showing location of trenches; contour lines not measured (credit: BULP).**

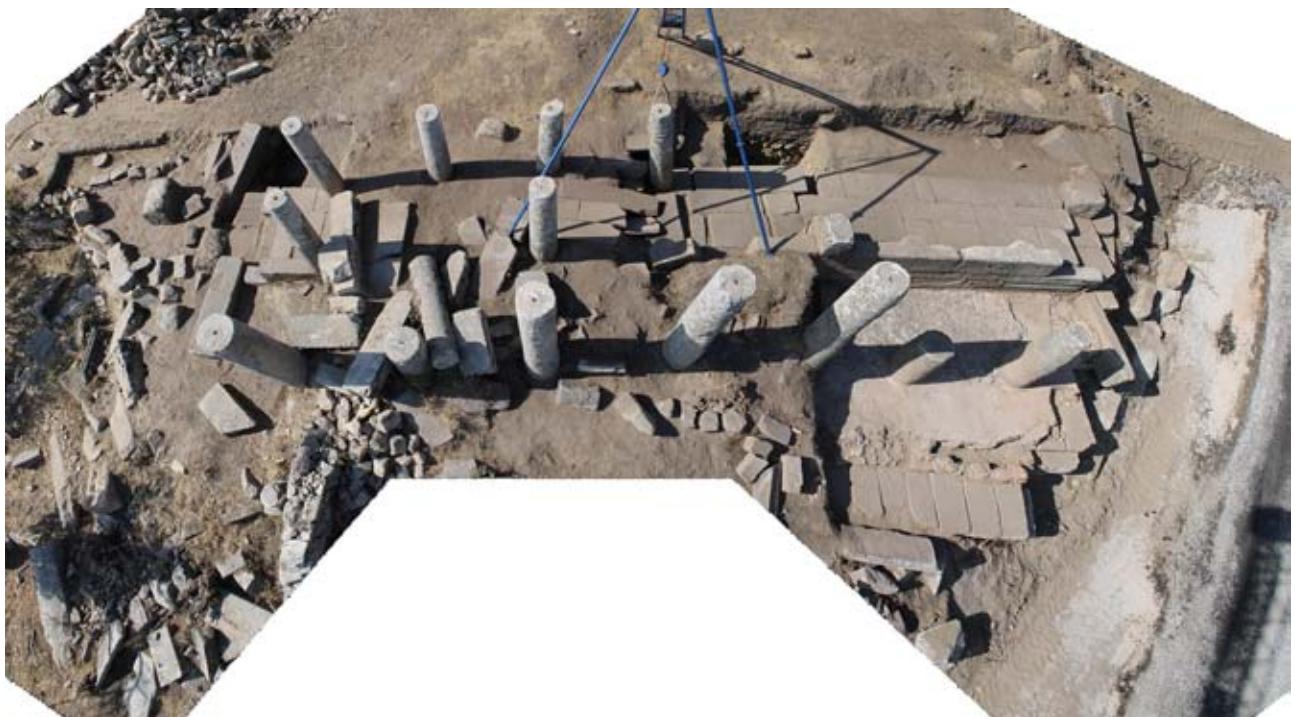
Fig. 87 : Aerial view of HB post excavation looking N across axis of HB (photo: BULP).

The fountain is composed of at least three rows of seven (or, less probably, nine) columns (see Fig. 83, 85-87). The column capitals are Doric, but the building does not conform to canonical classical architecture. The N façade of the **HB** flanks a narrow porch bound on the S by a low (0.55 m) parapet. On the parapet stands a second row of columns. The back of the parapet served as the wall of a large water basin that extended E-W probably for the full length of the building. A third row of columns stood in the water basin; we hypothesize that a fourth row of columns or a wall stood atop the S wall of the basin. The entire S side of the monument awaits further investigation since it currently lies under block tumble. The basin walls and at least those columns that stood in the water (row C) were

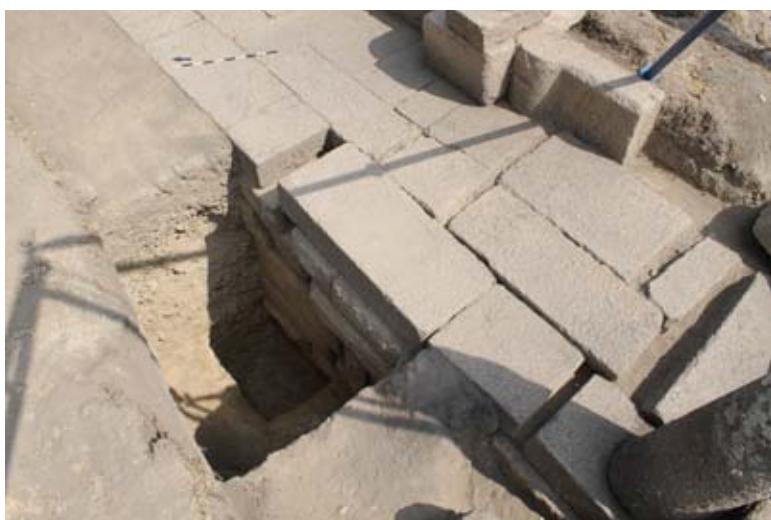
Fig. 88 : View of parapet, platform, and sondage in Trench A that reached bottom of foundation (photo: BULP).

tually provided an opportunity to study the history of occupation of the **HB** as well as the collapse and abandonment of the structure. Towards the end of the season, we excavated a sondage N of the platform in order to study the building's substructure and foundation (Fig. 88).

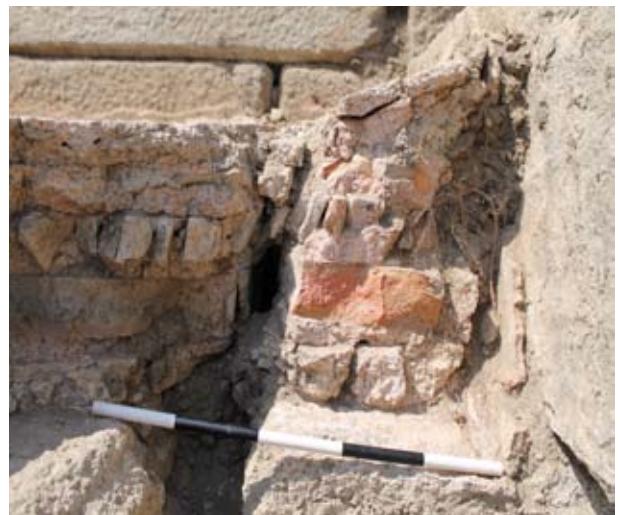
**Fig. 91 : Detail of successive layers of tile and plaster floors from NE corner of basin**  
(photo: BULP).

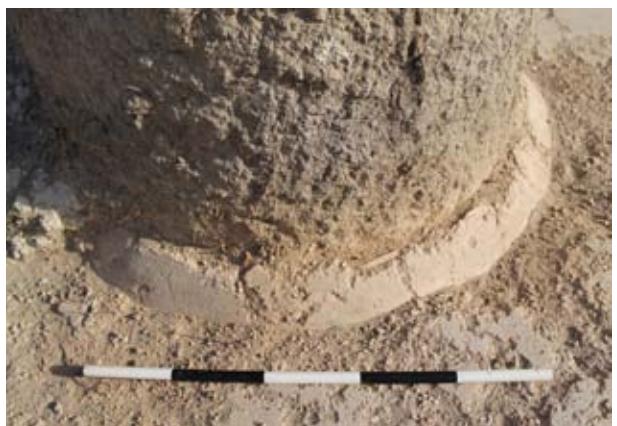
**Fig. 92 : Detail of plaster around bottom of column C6** (photo: BULP).

along all of its edges, including around the C-row column bases (Fig. 92). The two or more plaster floor layers below this remain unexcavated.

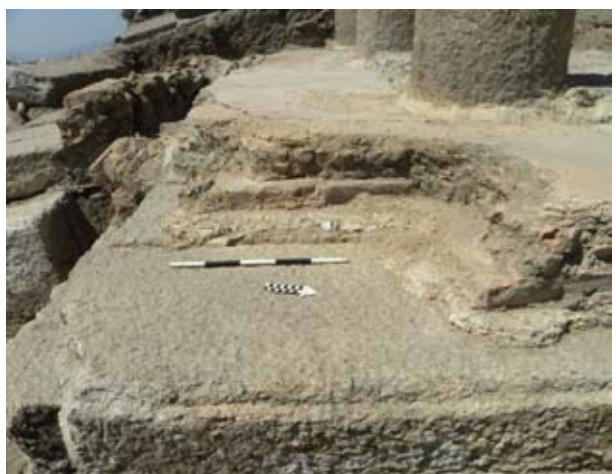
**Fig. 93 : Detail of bottom of basin, successive layers of tile and plaster, and disarticulated S section of basin** (photo: BULP).

In addition to the plaster floor, we exposed the gneiss blocks of the southern platform (see Fig. 91). The lack of plaster on the S portion of these blocks, in addition to horizontal plaster-filled grooves on them seem to indicate that the fountain had a thick back wall to contain the water. Nothing of the wall remains. In the S, the topmost course of the basin fell S at a later date because it was not clamped to the blocks directly N of it. This created a crevice along the southern extent of the plastered basin, which later filled with loose dirt (b12) (Fig. 93).

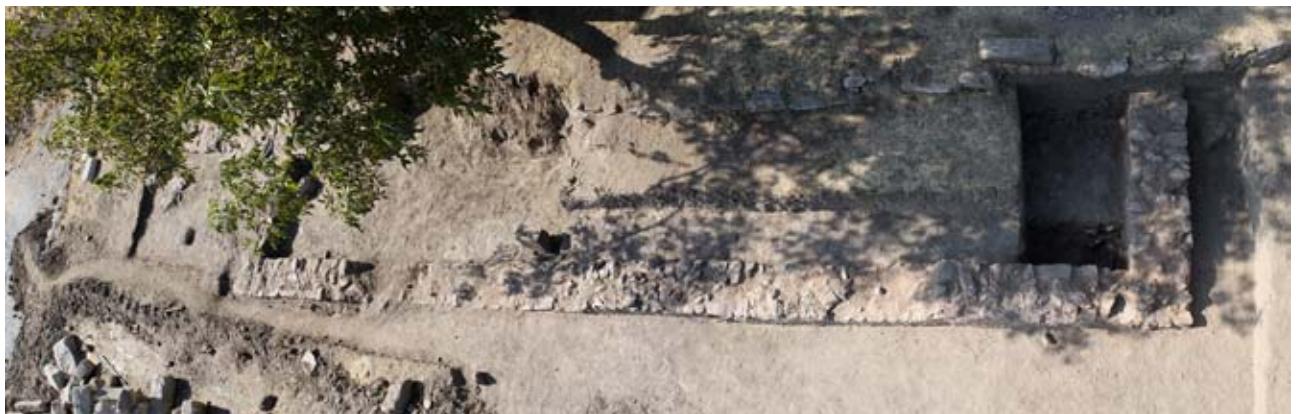
**Fig. 96 : Vue aérienne des tranchées 2 et 3 (photo : A. Waters).**

##### *Tranchées 2 et 3* (Fig. 96)

La tranchée 2 a commencé avec une superficie de 5 m par 5 m puis a été entendue afin de rejoindre la tranchée 1. Là aussi seules les terres arables ont été décapées. Les vestiges mis au jour se composent d'une très large structure formée par une série de murs connectés définissant un espace rectangulaire. Les murs sont composés de petits blocs liés par un mortier hydraulique rosâtre très fin. Seul le mur sud de la structure a été entièrement dégagé. Il présente une largeur de 80 cm et s'étend sur une longueur totale de 17,60 m. Un sondage profond a été creusé dans l'angle sud-est de la structure, afin de préciser sa composition, son état de conservation, sa chronologie ainsi que sa fonction. L'emprise du sondage est de 2,65 m par 1,50 m. La profondeur totale du creusement a été de 1,50 m. Il apparaît que les niveaux mis au jour correspondent à un remplissage dû au ruissellement des eaux de pluie. Au fond du sondage on récolte une large quantité de matériel

céramique, dont notamment une grande série de bol Cnidiens des I<sup>e</sup> et II<sup>e</sup> s. ap. J.-C. Ce niveau de remblai correspond également à une arrivée d'eau, dont on a mis au jour la canalisation qui perce le mur est de la structure. On remarque de nombreuses traces de mortier hydraulique couvrant les faces internes de cet ensemble qui s'apparente très probablement à un très grand bassin de récupération des eaux de pluie.

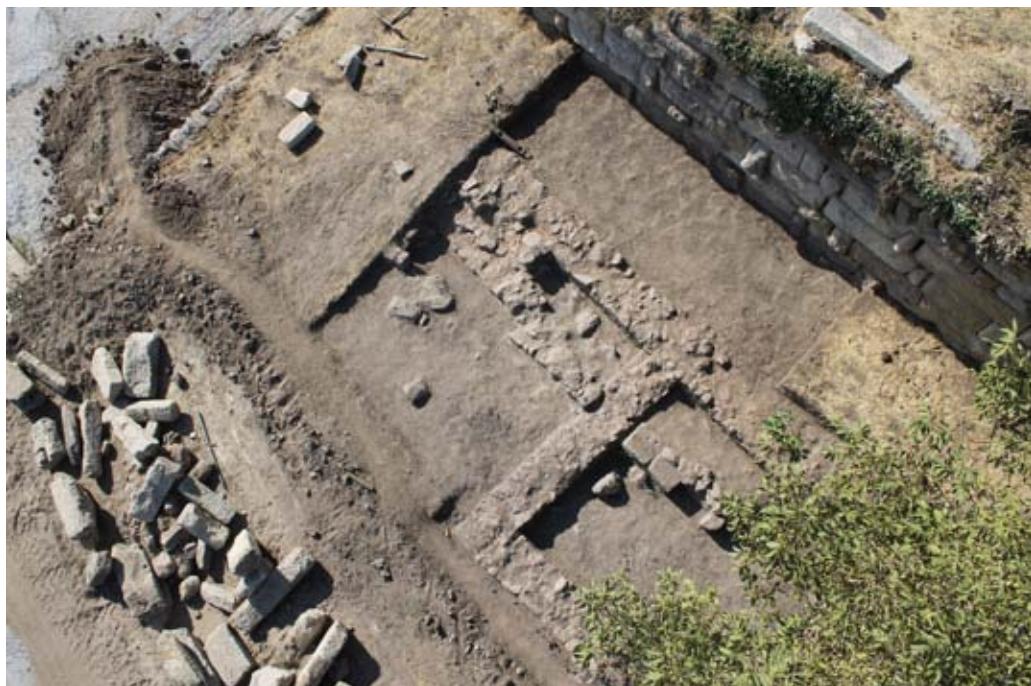
**Fig. 97 : Détail de la tranchée 3 et de l'organisation en cascade des bâtiments (photo : A. Waters).**

La tranchée 3 a permis de révéler que ce bassin semble s'articuler sur une deuxième structure, plus large, et avec laquelle il partage son mur nord. Il n'est pas impossible que cette deuxième structure soit elle aussi un bassin et que l'ensemble présente une série de réservoirs en cascade (Fig. 97).

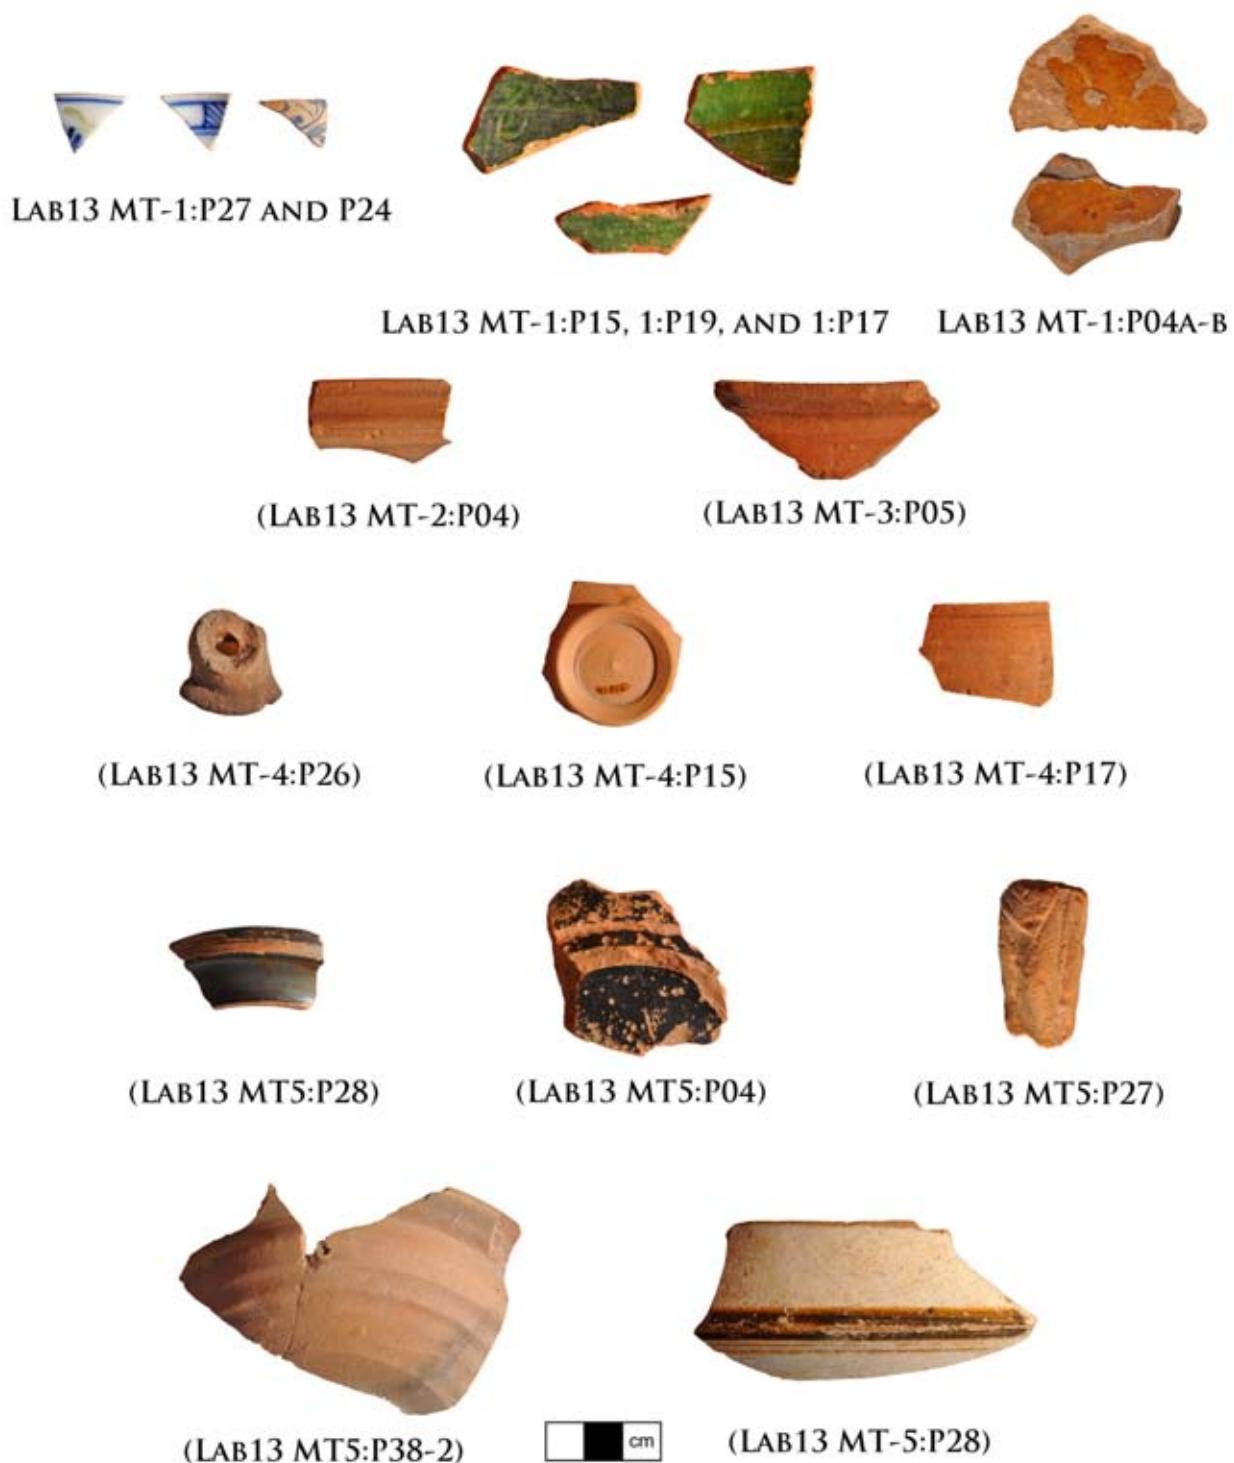
**Fig. 98:** Selection of pottery from Trench M1 (J. Blid & R. Hedlund).

##### *Pottery (Fig. 98)*
